VEHICLE INSPECTION REPORT

GK13XCR

Ford Kuga 2.0 TDCi Titanium 5dr 2WD

Eastbourne Car Auctions

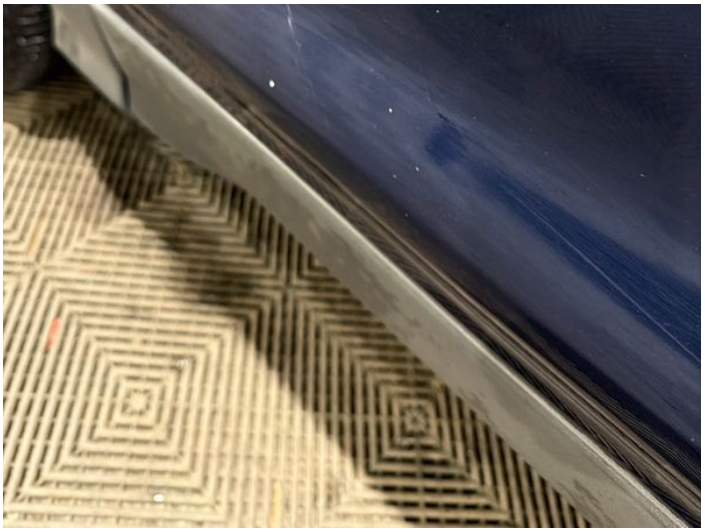
4: Bumper Front
Scratched
Over 100mm Thru Paint

5: Wheel nsf
Scratched
Up To 50mm

6: Wing nsf
Chipped
1 To 5

7: Screen Front
Chipped
Over 10mm

8: Door Mirror Assy osf
Scratched (Painted)
UpTo 25mm Thru Paint

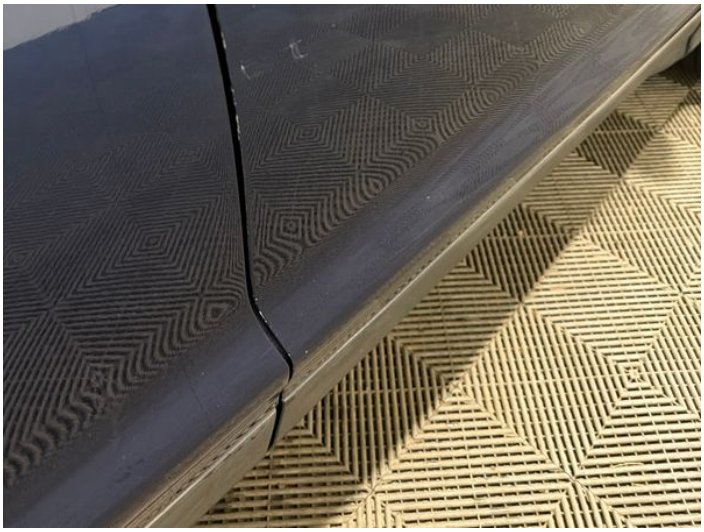
9: Door nsf
Dented
Over 2 UpTo 10mm

10: Door nsf
Scratched
UpTo 25mm Thru Paint

11: Door nsr
Chipped
Edge Chip

12: Wheel nsr
Scratched
Over 50mm

13: Qtr Panel nsr
Scratched
UpTo 25mm Thru Paint

14: Bumper Rear
Scratched
25 to 100mm Thru Paint

15: Bumper Rear Moulding
Scuffed (Unpainted)
Over 100mm

16: Boot Lid
Dented
With Paint Damage

17: Qtr Panel osr
Chipped
1 To 5
