VEHICLE INSPECTION REPORT

HT70CZG

BMW X6 xDrive30d MHT M Sport 5dr Step Auto

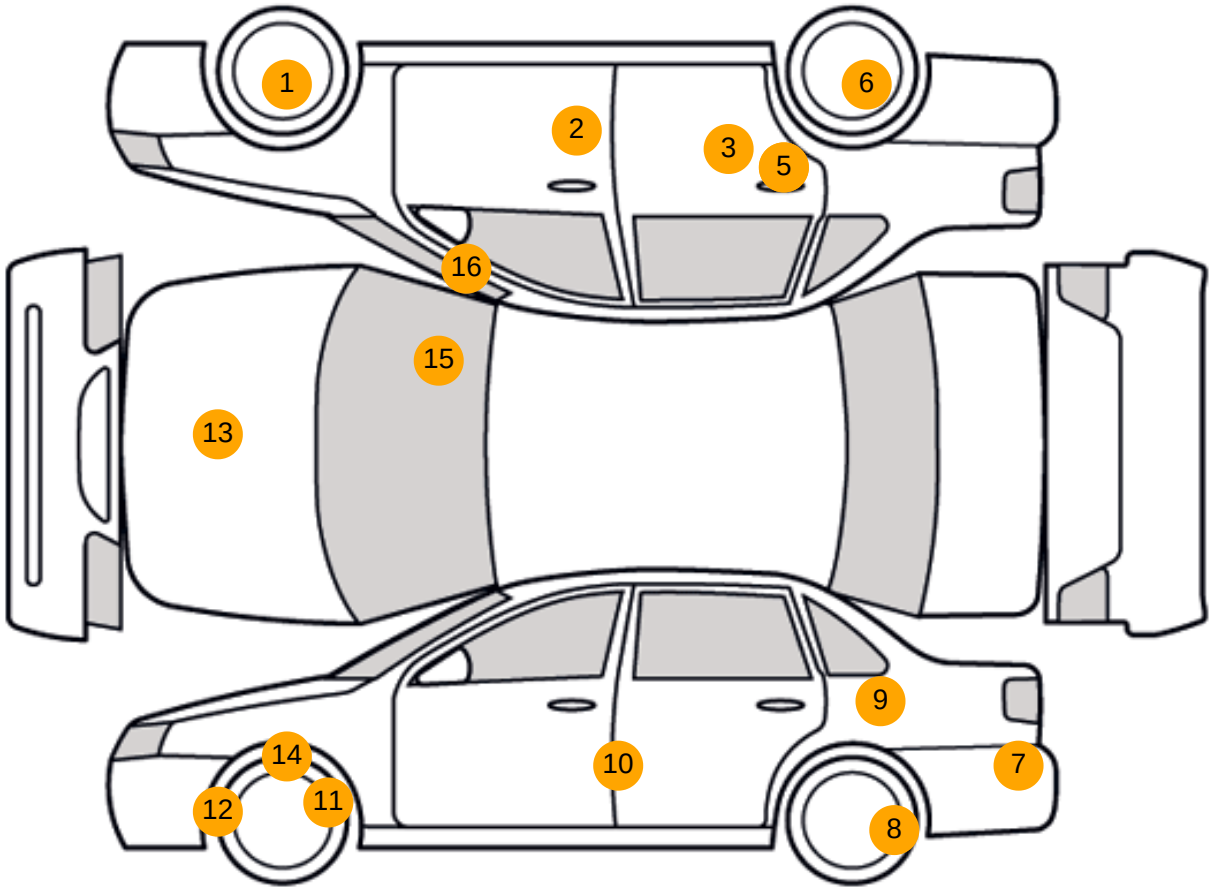
Damage Photos

1: Wheel osf
Scratched
Over 50mm

2: Door osf
Chipped
1 To 5

3: Door osr
Chipped
1 To 5

4: Door osr
Scratched
UpTo 25mm Thru Paint

5: Door osr
Chipped
Edge Chip

6: Wheel osr
Scratched
Over 50mm

7: Bumper Rear
Scratched
25 to 100mm Thru Paint

8: Wheel nsr
Scratched
Over 50mm

9: Qtr Panel nsr
Chipped
Edge Chip

10: Door nsf
Chipped
Edge Chip

11: Wheel nsf
Scratched
Over 50mm

12: Bumper Front
Scratched
25 to 100mm Thru Paint

13: Bonnet
Chipped
Multiple Chips

14: Wing Front Arch Extension ns
Scratched (Painted)
Over 25mm Thru Paint

15: Screen Front
Chipped
UpTo 10mm

16: A Post os
Dented
With Paint Damage

17: Tyre osr
Damaged
Replace
