VEHICLE INSPECTION REPORT

GY68KWZ

Ford Fiesta 1.5 TDCi 120 Titanium 5dr

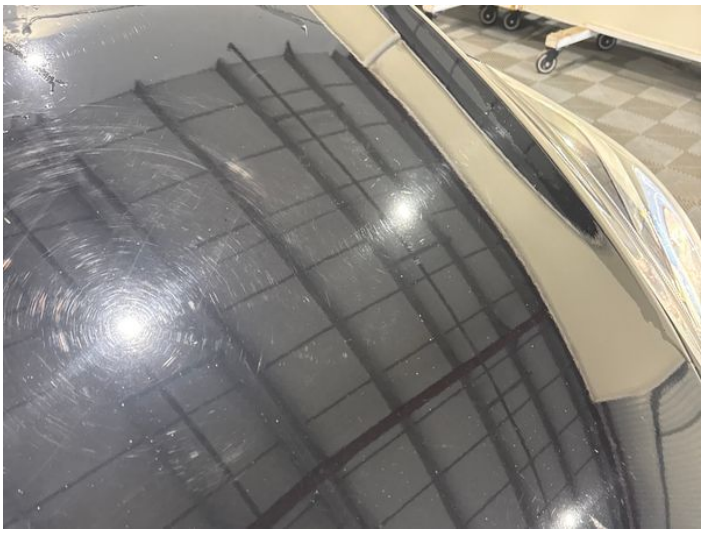
1: Other
N/A
N/A
Carpet in boot soiled

2: Bonnet
Chipped
Multiple Chips

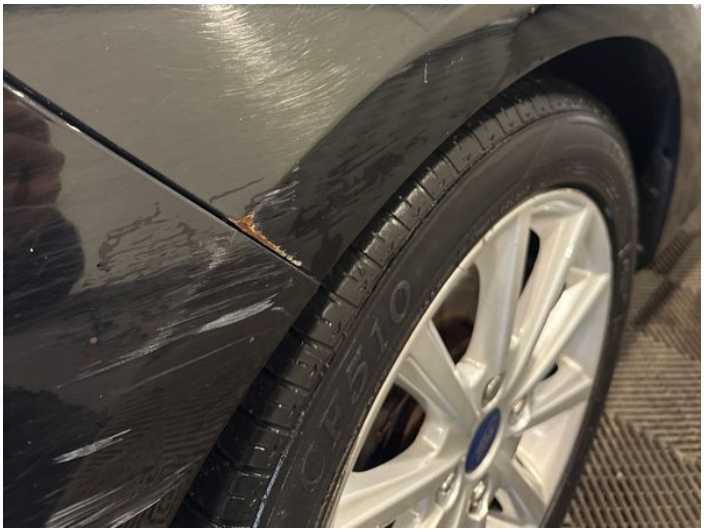
3: Bumper Front
Scratched
Over 100mm Thru Paint

4: Wing nsf
Dented
With Paint Damage

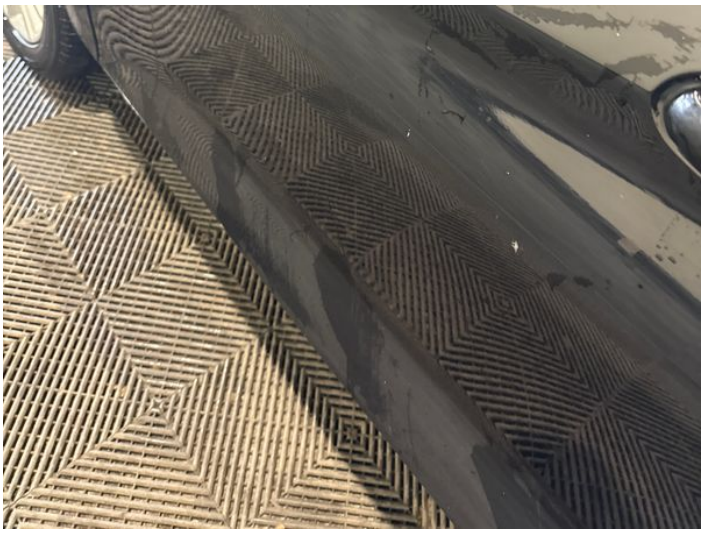
5: Wheel nsf
Scratched
Over 50mm

6: Door nsf
Dented
With Paint Damage

7: A Post ns
Scratched
Over 25mm Thru Paint

8: B Post ns
Scratched
Over 25mm Thru Paint

9: Door nsr
Chipped
1 To 5

10: Wheel nsr
Scratched
Over 50mm

11: Qtr Panel nsr
Dented
With Paint Damage

12: Bumper Rear
Insecure
Action Required

13: Bumper Rear
Scratched
25 to 100mm Thru Paint

14: Qtr Panel osr
Scratched
Over 25mm Thru Paint

15: Roof
Scratched
Over 25mm Thru Paint

16: Wheel osr
Scratched
Up To 50mm

17: Door osr
Dented
Between 10mm + 30mm
Multiple dents

18: Door osf
Dented
Over 30mm

19: Door osf
Chipped
Edge Chip

20: A Post os
Scratched
Over 25mm Thru Paint

21: Door Mirror Assy osf
Broken
Replace

22: Flasher Side Repeater os
Broken
Replace

23: Wing osf
Dented
With Paint Damage

24: Wheel osf
Scratched
Over 50mm

25: Screen Front
Chipped
UpTo 10mm

26: Tyre nsr
Damaged
Replace
