VEHICLE INSPECTION REPORT

YL19KKE

Skoda Kodiaq 1.5 TSI Sport Line 4x4 5dr DSG [7 Seat]

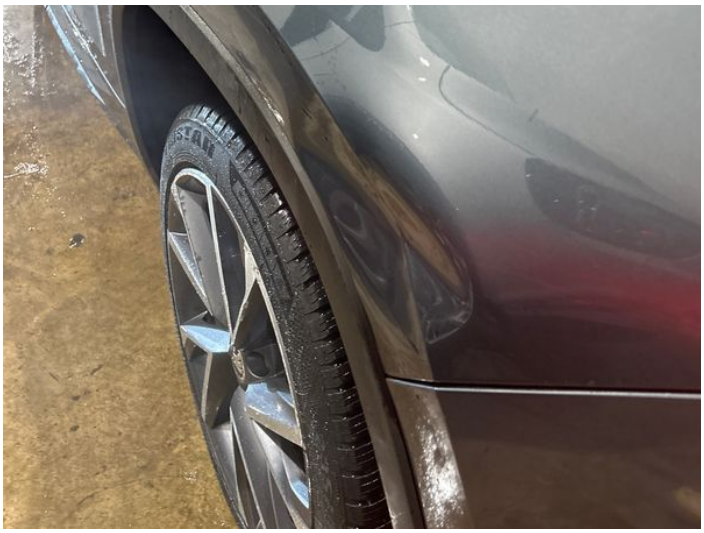
1: Wheel osf
Scratched
Over 50mm

2: Door osf
Chipped
1 To 5

3: Door osr
Chipped
1 To 5

4: Qtr Panel osr
Scratched
Over 25mm Thru Paint

5: Wheel osr
Corroded
Light

6: Qtr Panel nsr
Dented
Over 30mm

7: Wheel nsr
Scratched
Over 50mm

8: Door nsr
Chipped
1 To 5

9: Door nsf
Chipped
1 To 5

10: Wheel nsf
Scratched
Over 50mm

11: Wing nsf
Chipped
1 To 5

12: Bumper Front
Scratched
UpTo 25mm Thru Paint

13: Screen Front
Chipped
UpTo 10mm

14: Handle Inner osf
Damaged
Replace

15: Tyre nsf
Damaged
Replace

16: Tyre osr
Damaged
Replace
