VEHICLE INSPECTION REPORT

GL70OKB

Audi A4 40 TFSI 204 S Line 4dr S Tronic

nama GRADE 4

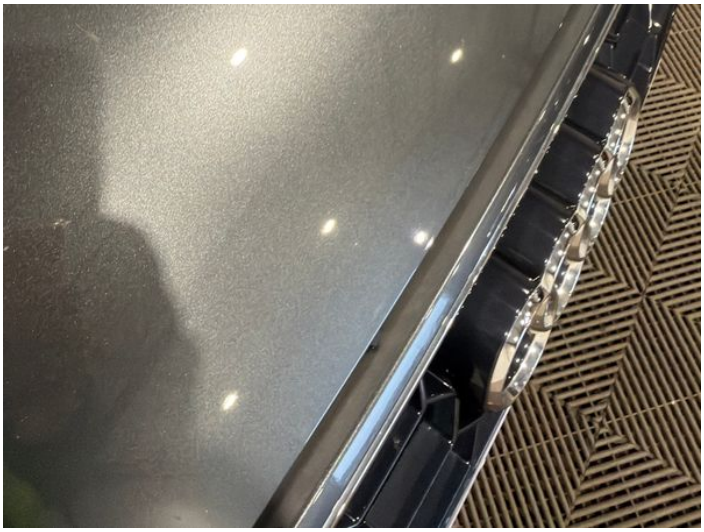
Damage Photos

1: Tyre nsf
Damaged
Replace

2: Tyre nsr
Damaged
Replace

3: Tyre osr
Damaged
Replace

4: Bonnet
Chipped
1 To 5

5: Bumper Front
Cracked
Over 25mm

6: Wheel nsf
Scratched
Over 50mm

7: Wing nsf
Scratched
Over 25mm Thru Paint

8: Door nsf
Dented
With Paint Damage

9: Door nsr
Dented
Between 10mm + 30mm

10: Door nsr
Chipped
1 To 5

11: Wheel nsr
Scratched
Over 50mm

12: Qtr Panel nsr
Scratched
UpTo 25mm Thru Paint

13: Bumper Rear
Cracked
UpTo 25mm

14: Qtr Panel osr
Scratched
UpTo 25mm Thru Paint

15: Wheel osr
Scratched
Over 50mm

16: Door osr
Chipped
1 To 5

17: Door osf
Chipped
Edge Chip

18: Wing osf
Chipped
1 To 5

19: Wheel osf
Scratched
Over 50mm
