VEHICLE INSPECTION REPORT

NK13ZNU

Audi A6 2.0 TDI S Line 4dr Multitronic

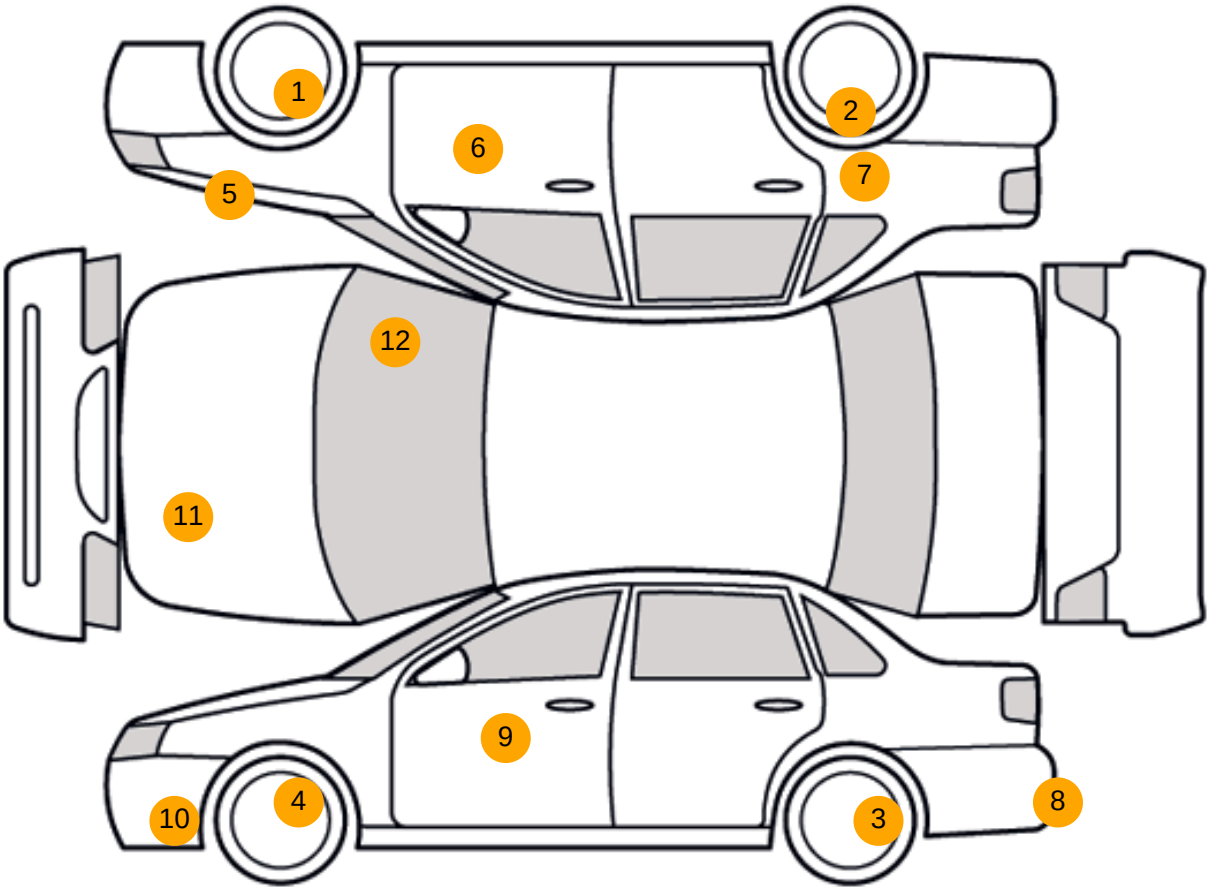
Damage Photos

1: Wheel osf
Scratched
Over 50mm

2: Wheel osr
Scratched
Up To 50mm

3: Wheel nsr
Scratched
Over 50mm

4: Wheel nsf
Scratched
Over 50mm

5: Wing osf
Chipped
1 To 5

6: Door osf
Scratched
Over 25mm Thru Paint

7: Qtr Panel osr
Chipped
1 To 5

8: Bumper Rear
Scratched
25 to 100mm Thru Paint

9: Door nsf
Poor Previous Repair
Poor Paint

10: Bumper Front
Scratched
Over 100mm Thru Paint

11: Bonnet
Chipped
1 To 5

12: Screen Front
Chipped
UpTo 10mm
