VEHICLE INSPECTION REPORT

EK11VWG

Ford Fiesta 1.6 TDCi [95] Econetic 5dr [AC]

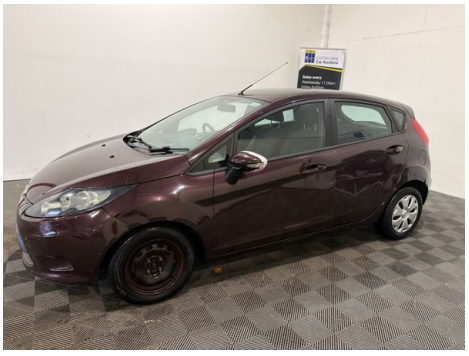
NSF	BUDGET	5.0mm
NSR	BUDGET	5.0mm
OSF	BUDGET	5.0mm
OSR	LASSA	5.0mm
Spare

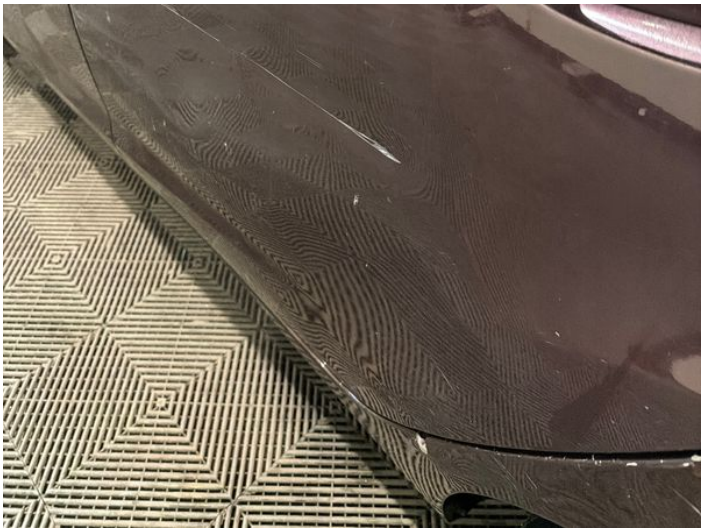
1: Seat Base Cover osr
Soiled
Light

2: Other
N/A
N/A
Carpet in boot soiled

3: Bonnet
Scratched
Over 25mm Thru Paint

4: Bumper Front
Cracked
Over 25mm

5: Wing nsf
Dented
With Paint Damage

6: Wheel Trim nsf
Missing
Replace

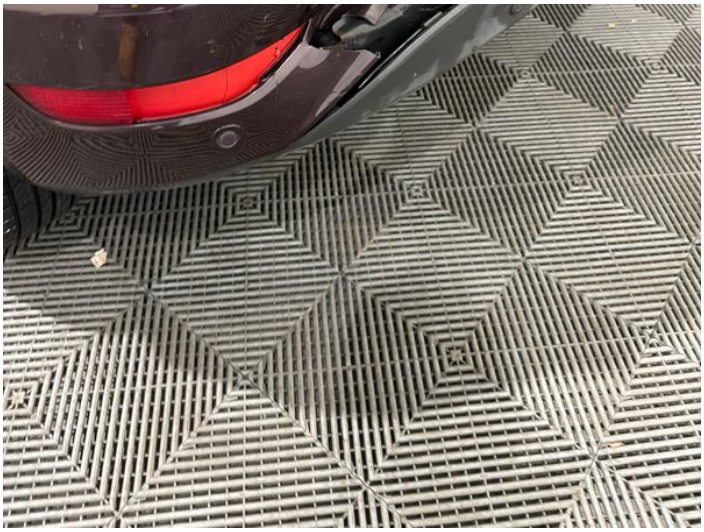
7: Door Mirror Assy nsf
Broken
Replace

8: A Post ns
Scratched
UpTo 25mm Thru Paint

9: Door nsf
Dented
Over 30% Of Panel

10: Door nsr
Dented
Over 30% Of Panel

11: Sill ns
Dented
With Paint Damage

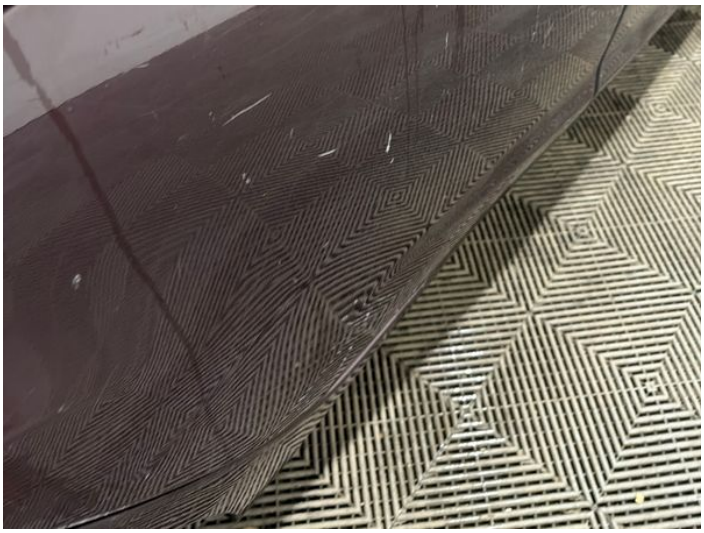
12: B Post ns
Dented
With Paint Damage

13: C Post ns
Scratched
Over 25mm Thru Paint

14: Qtr Panel nsr
Dented
With Paint Damage

15: Bumper Rear
Cracked
Over 25mm

16: Boot Lid
Dented
With Paint Damage
