VEHICLE INSPECTION REPORT

GY60LSO

Volkswagen Scirocco 2.0 TSI 210 GT 3dr DSG

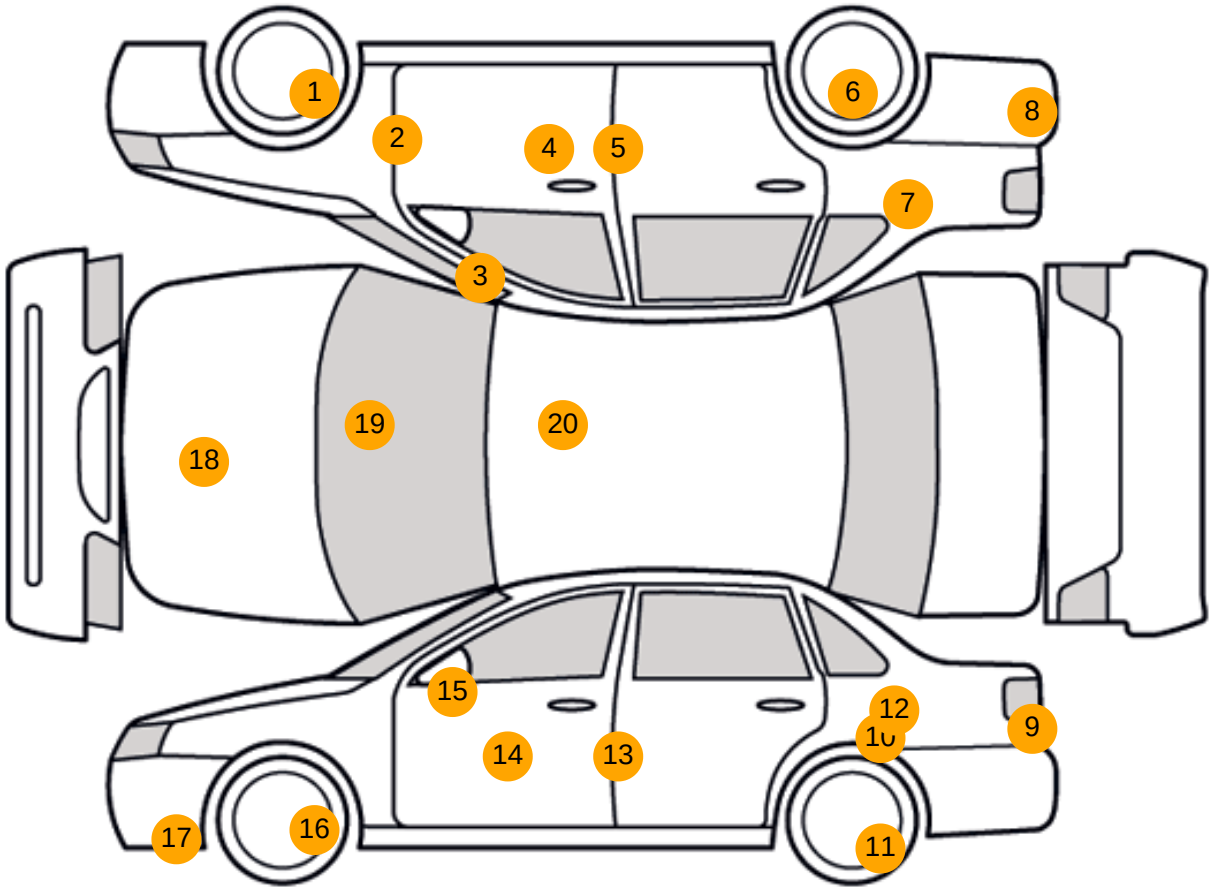
1: Wheel osf
Scratched
Over 50mm

2: Wing osf
Dented
Over 30mm

3: A Post os
Chipped
1 To 5

4: Door osf
Chipped
1 To 5

5: Door osf
Chipped
Edge Chip

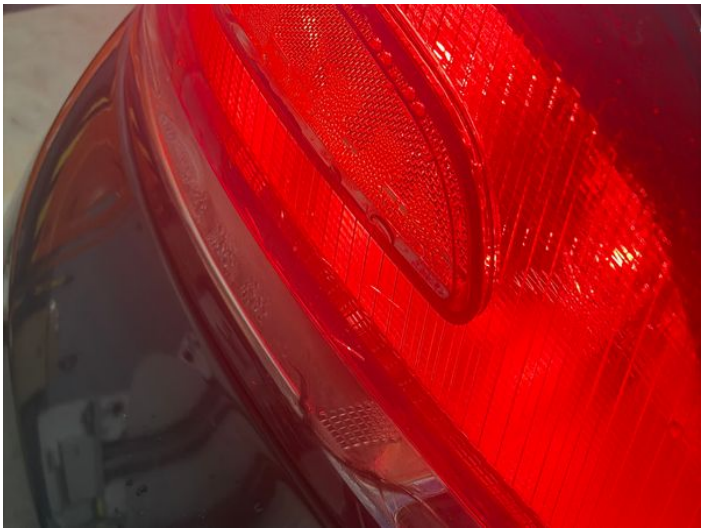
6: Wheel osr
Scratched
Over 50mm

7: Qtr Panel osr
Poor Previous Repair
Poor Paint

8: Bumper Rear
Scratched
25 to 100mm Thru Paint

9: Lamp nsr
Broken
Replace

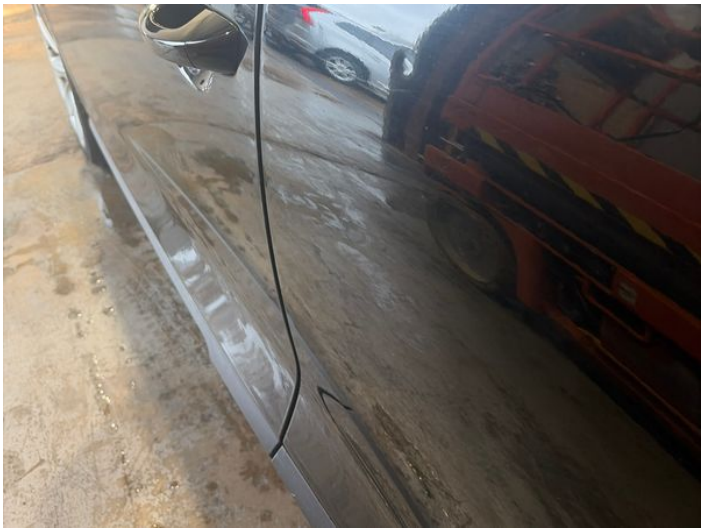
10: Qtr Panel nsr
Dented
Between 10mm + 30mm

11: Wheel nsr
Scratched
Over 50mm

12: Qtr Panel nsr
Chipped
1 To 5

13: Door nsf
Chipped
Edge Chip

14: Door nsf
Chipped
1 To 5

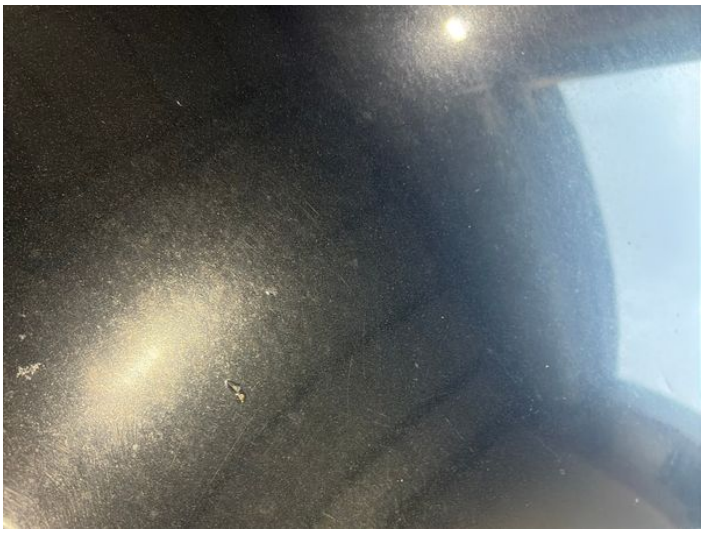
15: Door Mirror Assy nsf
Scratched (Painted)
UpTo 25mm Thru Paint

16: Wheel nsf
Scratched
Over 50mm

17: Bumper Front
Scratched
Over 100mm Thru Paint

18: Bonnet
Chipped
Multiple Chips

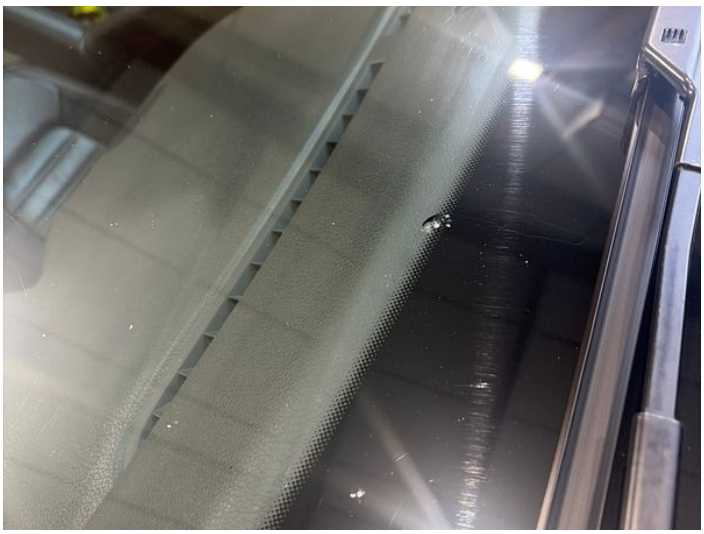
19: Screen Front
Chipped
UpTo 10mm

20: Roof
Chipped
1 To 5

21: Tyre osf
Damaged
Replace

22: Tyre osr
Damaged
Replace
