VEHICLE INSPECTION REPORT

HV71NLY

Skoda Scala 1.5 TSI SE L 5dr

nama GRADE 2

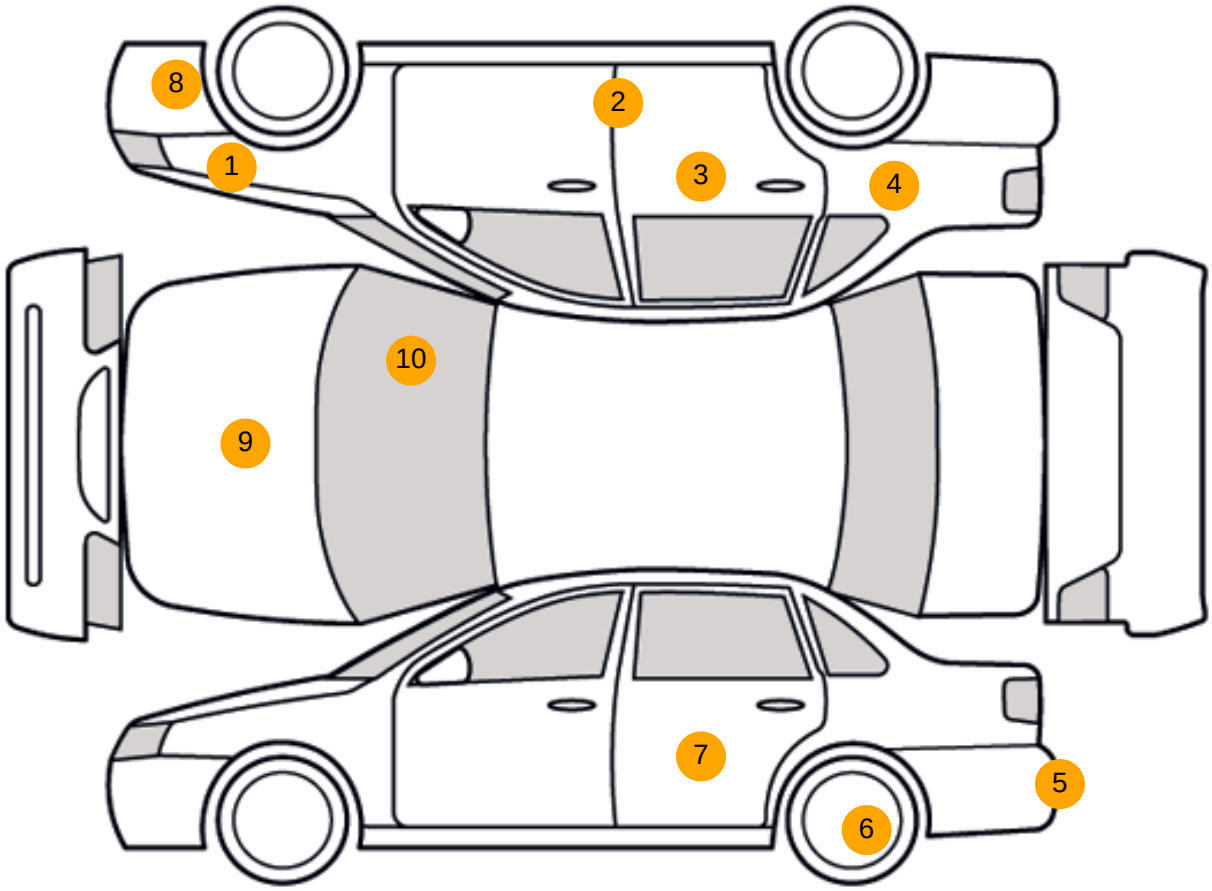
1: Wing osf
Chipped
1 To 5

2: Door osf
Chipped
Edge Chip

3: Door osr
Chipped
1 To 5

4: Qtr Panel osr
Scratched
UpTo 25mm Thru Paint

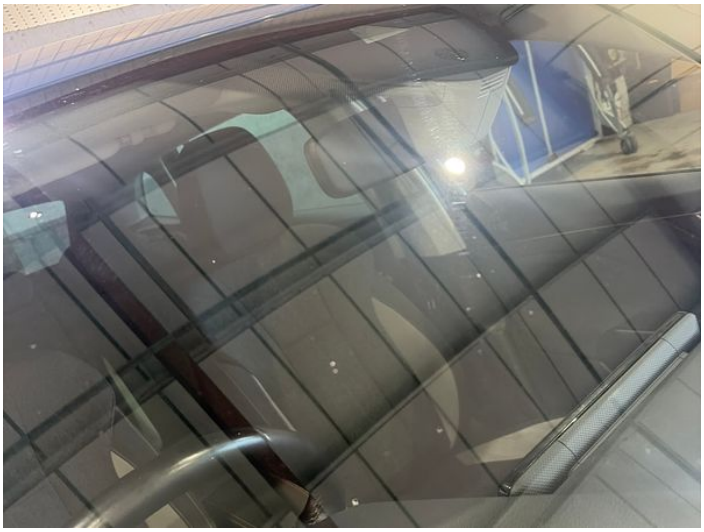
9: Bonnet
Chipped
1 To 5

10: Screen Front
Chipped
UpTo 10mm
