VEHICLE INSPECTION REPORT

RV66ZXD

Ford Kuga 2.0 TDCi 150 Titanium 5dr 2WD

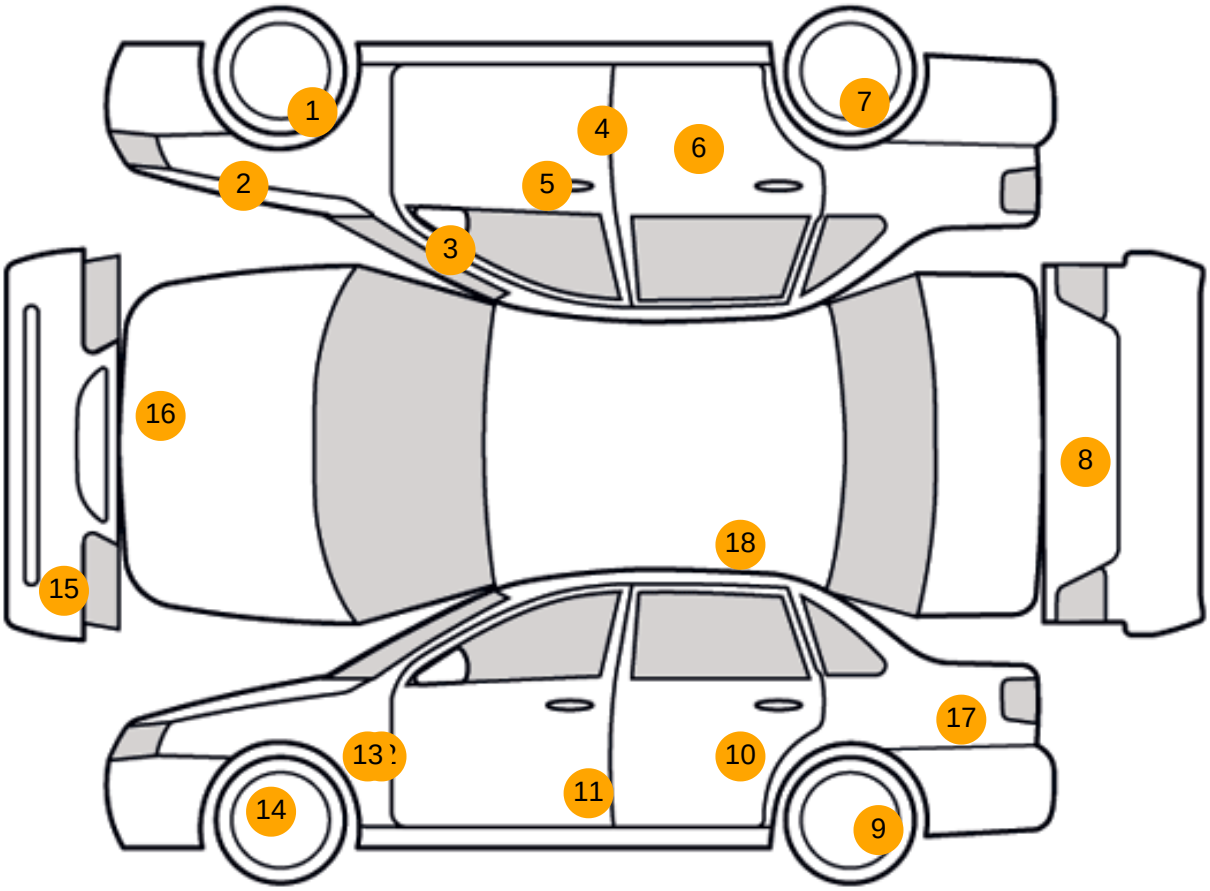
Condition Check

1: Wheel osf
Scratched
Over 50mm

2: Wing osf
Dented
With Paint Damage

3: Door Mirror Assy osf
Scratched (Painted)
UpTo 25mm Thru Paint

4: Door osf
Chipped
Edge Chip

5: Door osf
Dented
Between 10mm + 30mm

6: Door osr
Chipped
1 To 5

7: Wheel osr
Scratched
Over 50mm

8: Boot Lid
Chipped
1 To 5

9: Wheel nsr
Scratched
Over 50mm

10: Door nsr
Dented
Over 30mm

11: Door nsf
Dented
Between 10mm + 30mm

12: Wing nsf
Scratched
UpTo 25mm Thru Paint

13: Wing nsf
Chipped
1 To 5

14: Wheel nsf
Scratched
Over 50mm

15: Bumper Front
Chipped
Multiple Chips

16: Bonnet
Chipped
1 To 5

17: Qtr Panel nsr
Scratched
Over 25mm Thru Paint

18: Other
N/A
N/A
Roof rails scratched
