VEHICLE INSPECTION REPORT

KW15CYA

Kia Sportage 1.6 GDi ISG 2 5dr

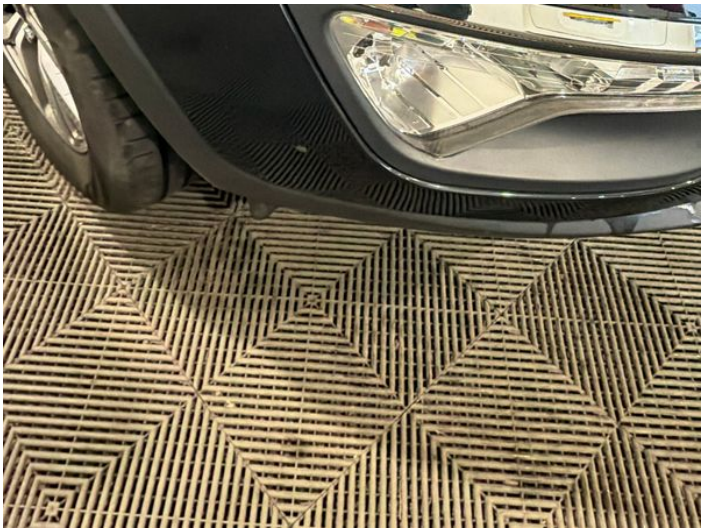
2: Bonnet
Scratched
Over 25mm Thru Paint

3: Bumper Front
Chipped
1 To 5

4: Bumper Front
Chipped
1 To 5

5: Wheel nsf
Scratched
Over 50mm

6: Wing nsf
Scratched
UpTo 25mm Thru Paint

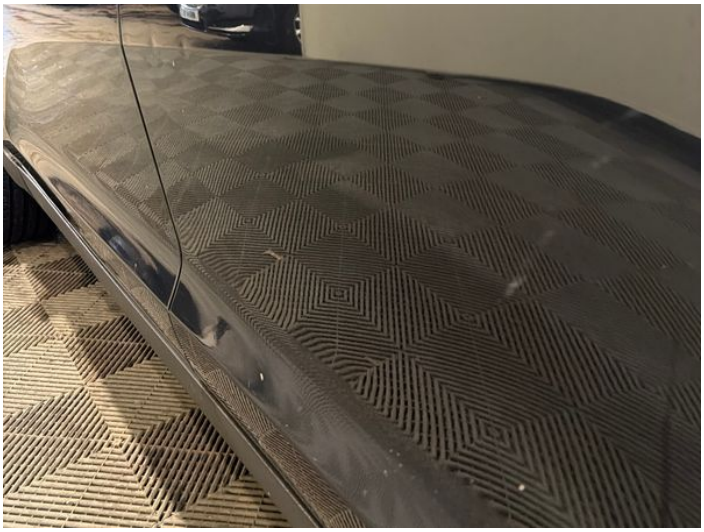
7: Door nsf
Dented
Between 10mm + 30mm

8: Door nsf
Chipped
Multiple Chips

9: Door nsr
Scratched
Over 25mm Thru Paint

10: Door nsr
Dented
Over 30mm

11: Wheel nsr
Scratched
Over 50mm

12: B Post ns
Dented
Over 2 UpTo 10mm

13: Qtr Panel nsr
Scratched
UpTo 25mm Thru Paint

14: Bumper Rear
Scratched
25 to 100mm Thru Paint

15: Boot Lid
Scratched
UpTo 25mm Thru Paint

16: Qtr Panel osr
Scratched
Over 25mm Thru Paint

17: Door osr
Chipped
Over 5mm

18: Door osr
Dented
Over 2 UpTo 10mm

19: Door osf
Scratched
Over 25mm Thru Paint

20: Wing osf
Scratched
Over 25mm Thru Paint

21: Wheel osf
Scratched
Over 50mm
