VEHICLE INSPECTION REPORT

OE66ZNT

Vauxhall Mokka X 1.4T Active 5dr

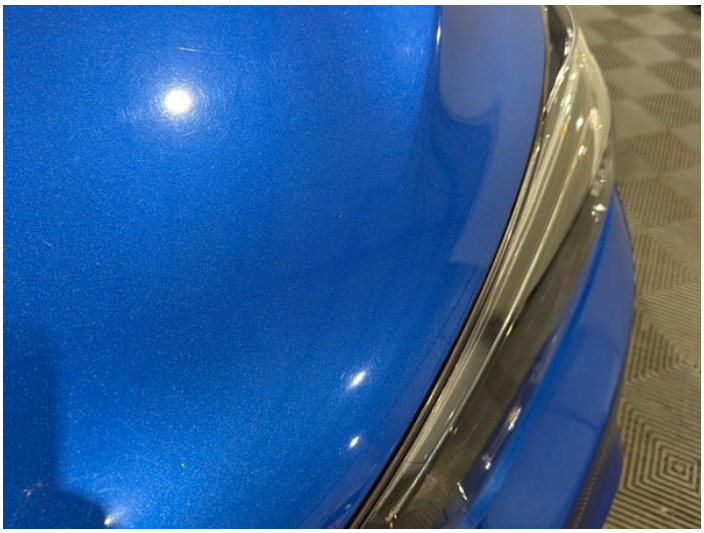
1: Centre Console Front
Scuffed
UpTo 25mm

2: Bonnet
Chipped
1 To 5

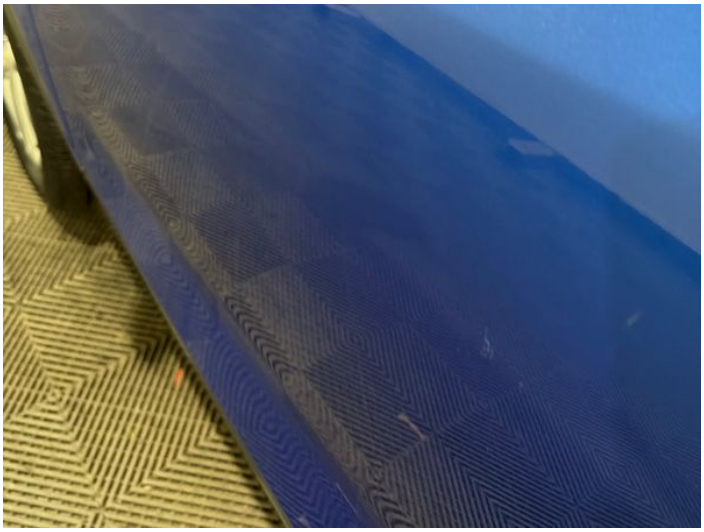
6: Wing nsf
Chipped
1 To 5

7: Door Mirror Assy nsf
Scratched (Painted)
Over 25mm Thru Paint

8: A Post ns
Chipped
1 To 5

9: Door nsf
Dented
2 Or Less UpTo 10mm

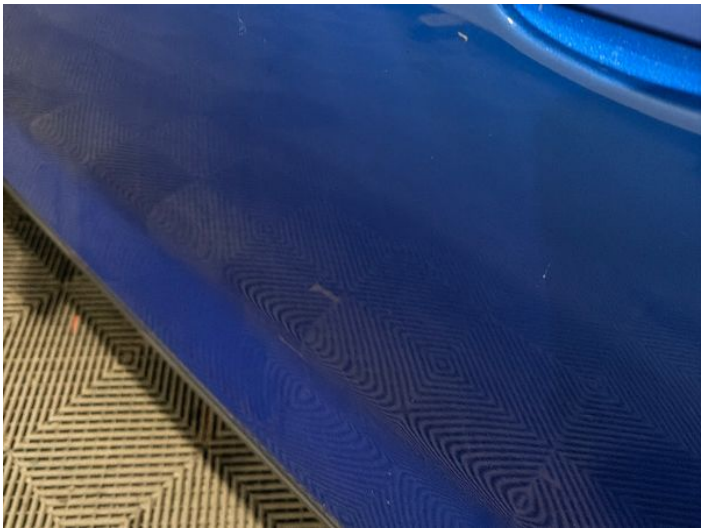
10: Door nsf
Chipped
1 To 5

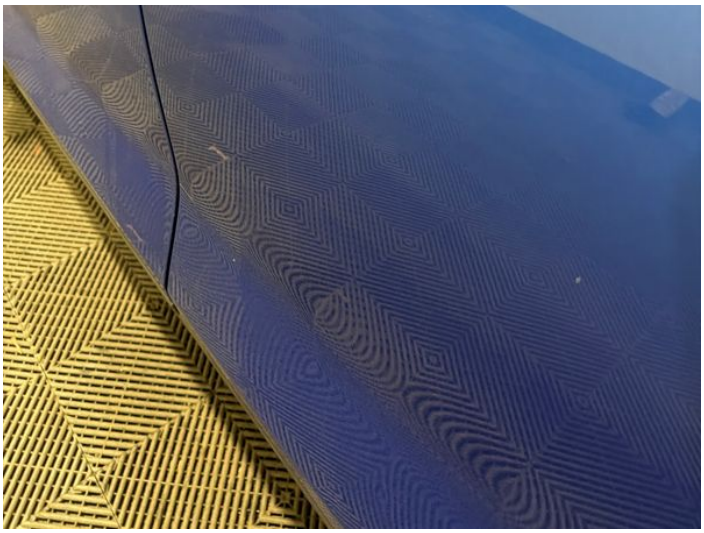
11: Door nsr
Dented
Between 10mm + 30mm

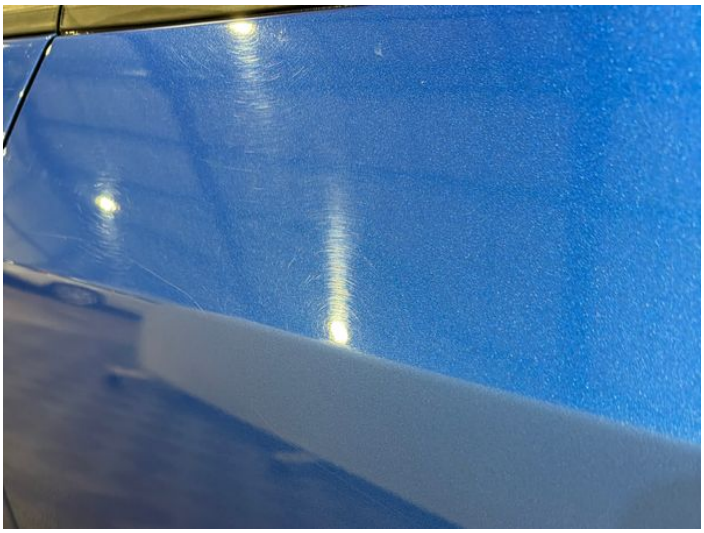
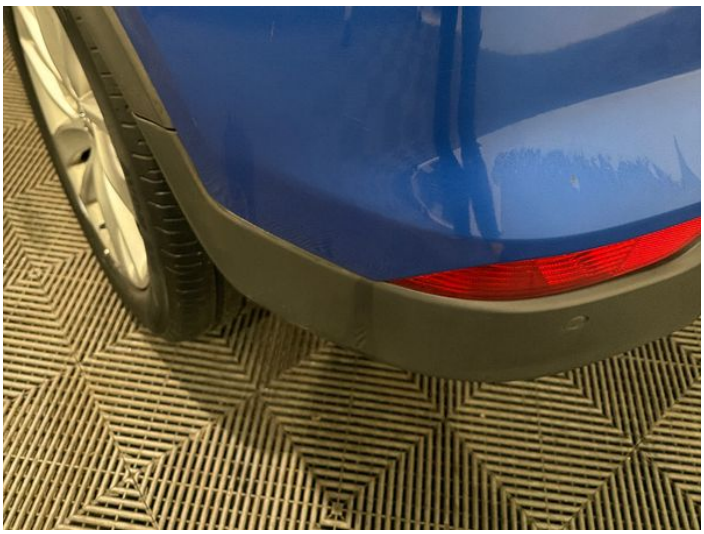
12: Door nsr
Scratched
Over 25mm Thru Paint

13: Bumper Rear
Scratched
Up To 25mm Thru Paint

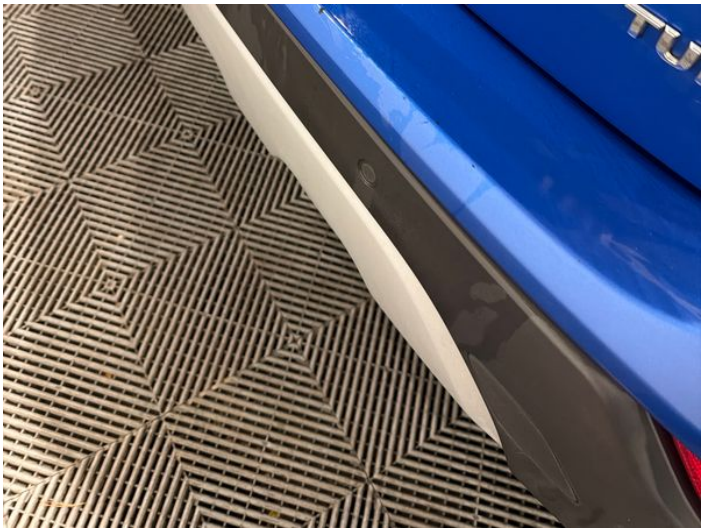
14: Boot Lid
Scratched
Over 25mm Thru Paint

15: Bumper Rear
Chipped
1 To 5

16: Door osr
Chipped
1 To 5

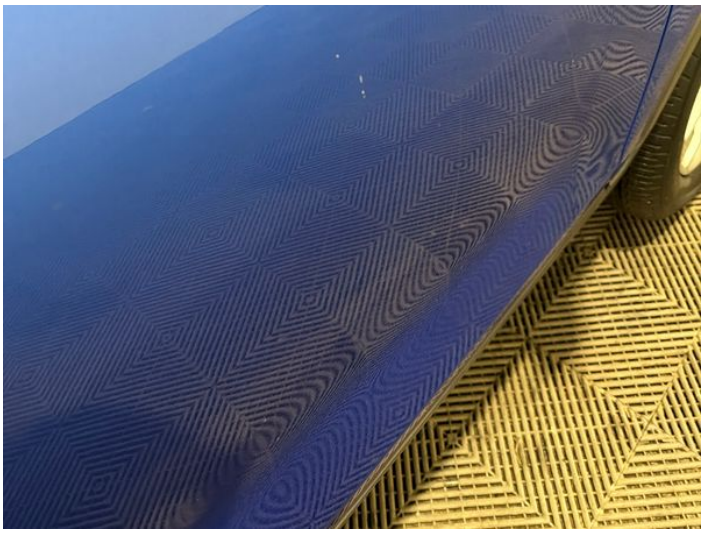
17: Door osf
Chipped
Edge Chip

18: Door osf
Chipped
1 To 5

19: Wing osf
Chipped
1 To 5

20: Wheel osf
Scratched
Up To 50mm

21: Screen Front
Chipped
UpTo 10mm
