VEHICLE INSPECTION REPORT

WN14YKT

Jaguar XF 2.2d [200] Premium Luxury 4dr Auto

Eastbourne Car Auctions

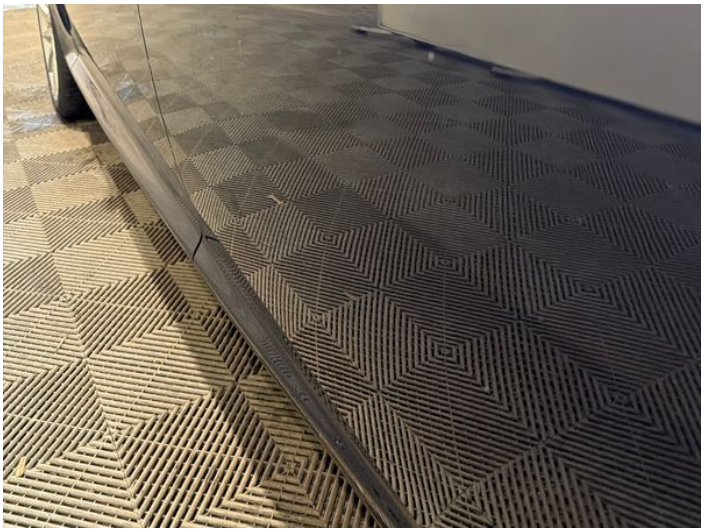
2: Tyre osf
Damaged
Replace

3: Bonnet
Scratched
Over 25mm Thru Paint

4: Bumper Front
Poor Previous Repair
Paint Flake

5: Wheel nsf
Scratched
Over 50mm

6: Wing nsf
Scratched
UpTo 25mm Thru Paint

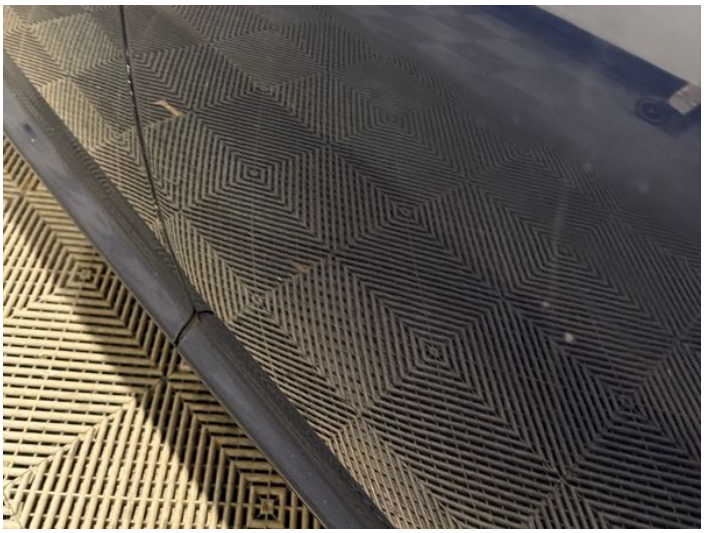
7: Door nsf
Scratched
Over 25mm Thru Paint

8: B Post ns
Scratched
Over 25mm Thru Paint

9: Door nsf
Dented
Over 2 UpTo 10mm

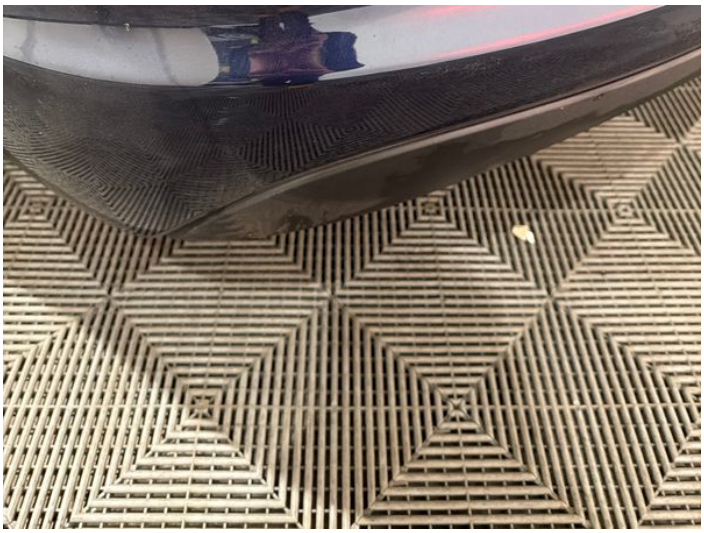
10: Door nsr
Dented
Between 10mm + 30mm
Multiple dents

11: Door nsr
Scratched
Over 25mm Thru Paint

12: Qtr Panel nsr
Chipped
1 To 5

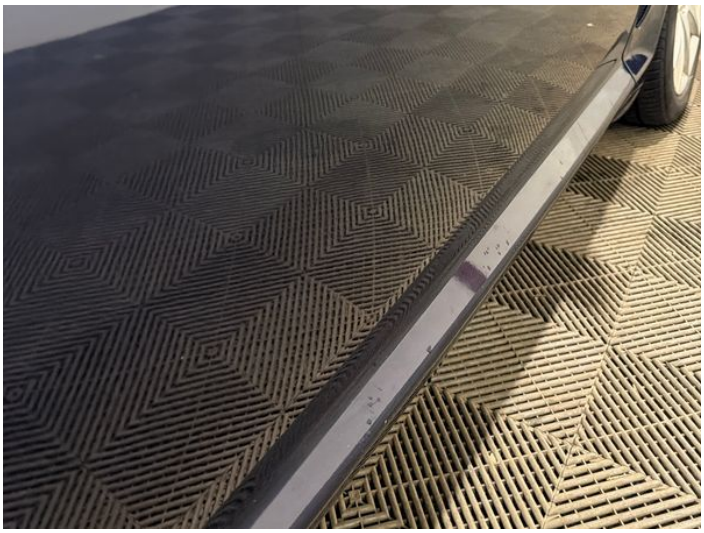
14: Bumper Rear
Scratched
Up To 25mm Thru Paint

15: Bumper Rear
Scratched
25 to 100mm Thru Paint

16: Boot Lid
Chipped
1 To 5

17: Qtr Panel osr
Scratched
Over 25mm Thru Paint

18: Wheel osr
Scratched
Over 50mm

19: Roof
Scratched
Over 25mm Thru Paint
