VEHICLE INSPECTION REPORT

HN70PNU

Ford Puma 1.0 EcoBoost Hybrid mHEV ST-Line 5dr

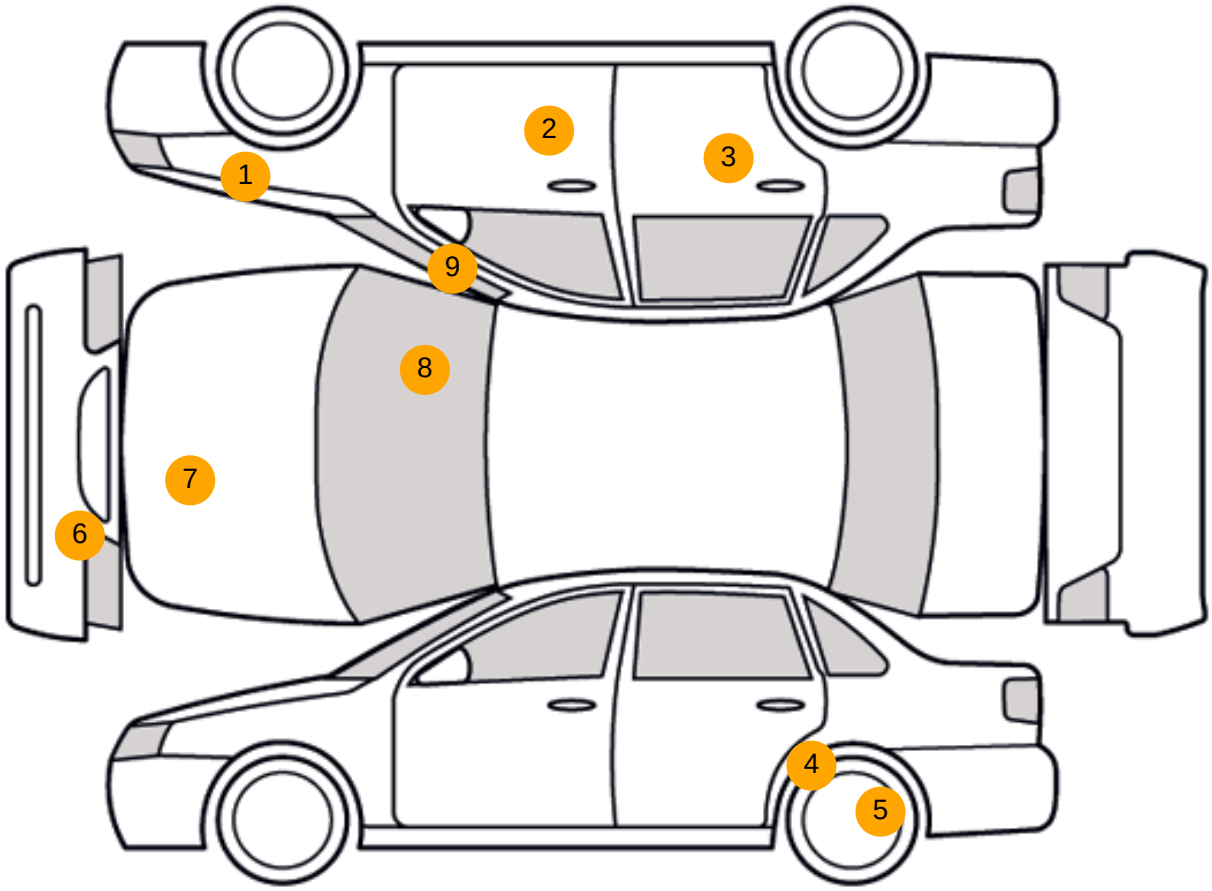
1: Wing osf
Chipped
1 To 5

2: Door osf
Chipped
1 To 5

3: Door osr
Chipped
1 To 5

4: Door nsr
Chipped
Edge Chip

5: Wheel nsr
Scratched
Up To 50mm

6: Bumper Front
Chipped
1 To 5

7: Bonnet
Chipped
1 To 5

8: Screen Front
Chipped
UpTo 10mm

9: A Post os
Chipped
1 To 5
