VEHICLE INSPECTION REPORT

YH14YPK

Vauxhall Corsa 1.2 Sting 3dr

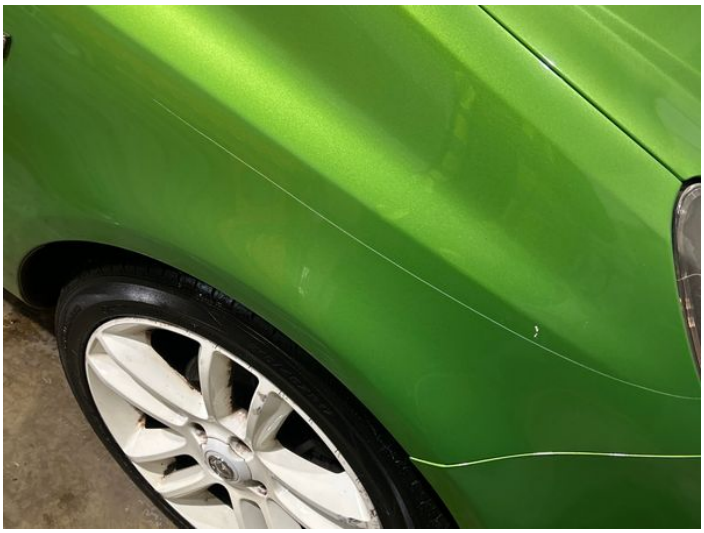
1: Wheel osf
Scratched
Over 50mm

2: Wing osf
Scratched
Over 25mm Thru Paint

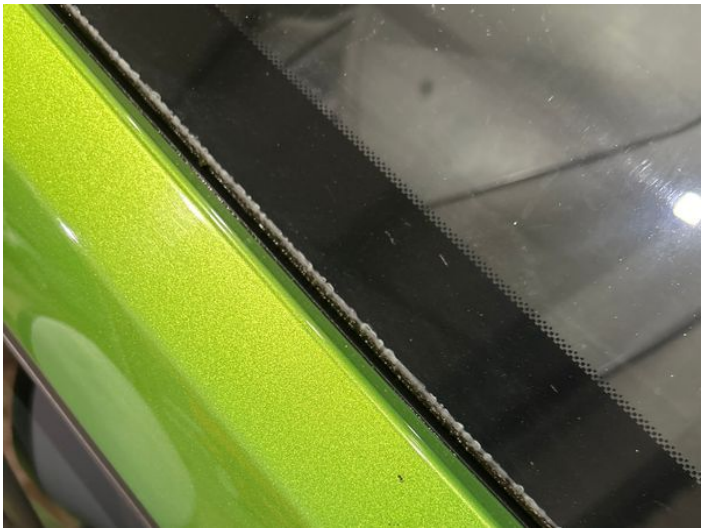
3: Other
N/A
N/A

4: A Post os
Chipped
1 To 5

5: Door osf
Poor Previous Repair
Paint Flake

6: Qtr Panel osr
Chipped
1 To 5

7: Wheel osr
Scratched
Up To 50mm

8: Bumper Rear
Dented
With Paint Damage

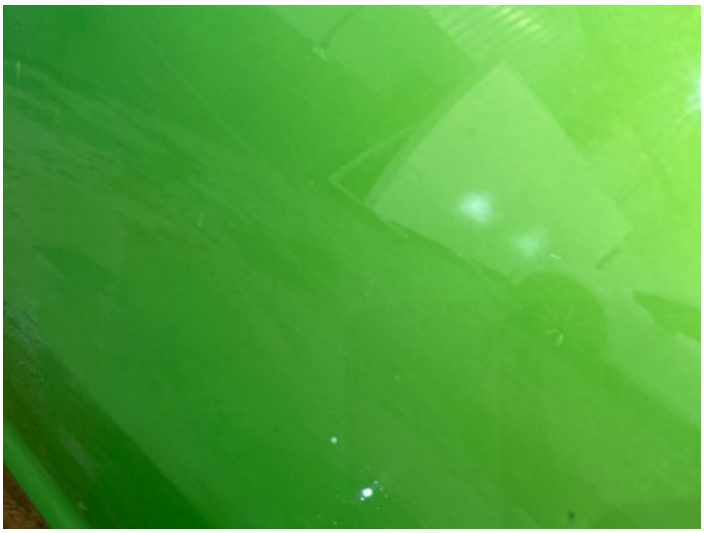
9: Boot Lid
Scratched
Over 25mm Thru Paint

10: Wheel nsr
Scratched
Over 50mm

11: Qtr Panel nsr
Chipped
1 To 5

12: Door nsf
Chipped
1 To 5

13: Door nsf
Chipped
Edge Chip

14: Wheel nsf
Scratched
Over 50mm

15: Bonnet
Dented
With Paint Damage
