VEHICLE INSPECTION REPORT

GN15YMW

Kia Rio 1.25 SR7 5dr

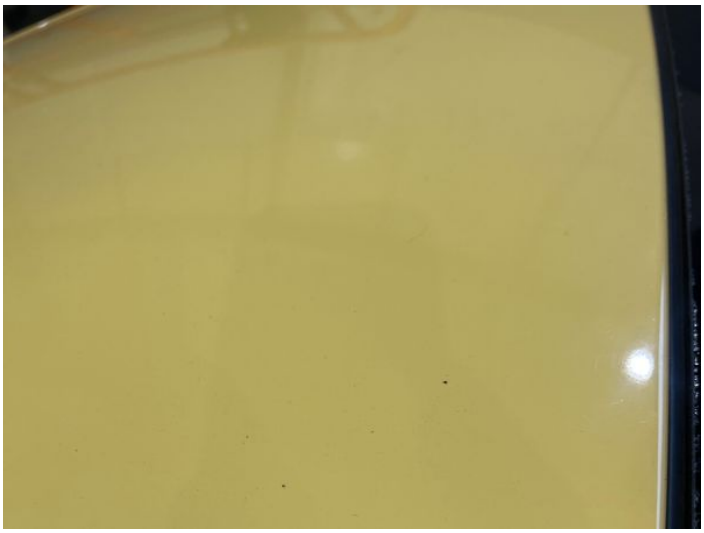
1: Wheel osf
Scratched
Over 50mm

2: Wing osf
Chipped
1 To 5

3: Door osf
Chipped
1 To 5

4: Door osr
Chipped
Multiple Chips

5: Qtr Panel osr
Dented
With Paint Damage

6: Wheel osr
Scratched
Over 50mm

7: Bumper Rear
Scratched
Over 100mm Thru Paint

8: Boot Lid
Chipped
1 To 5

9: Qtr Panel nsr
Dented
Between 10mm + 30mm

10: Wheel nsr
Scratched
Over 50mm

11: Door nsf
Chipped
1 To 5

12: Door Mirror Assy nsf
Scratched (Painted)
Over 25mm Thru Paint

13: Wheel nsf
Scratched
Over 50mm

14: Wing nsf
Chipped
1 To 5

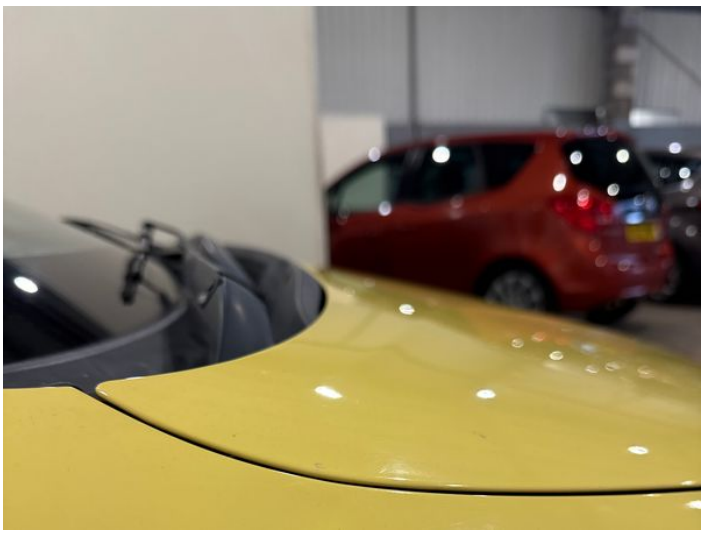
15: Bumper Front
Scratched
Over 100mm Thru Paint

16: Bonnet
Chipped
1 To 5

17: A Post os
Chipped
1 To 5

18: Roof
Chipped
1 To 5
