VEHICLE INSPECTION REPORT

GK66GNF

Vauxhall Adam 1.4i Glam 3dr

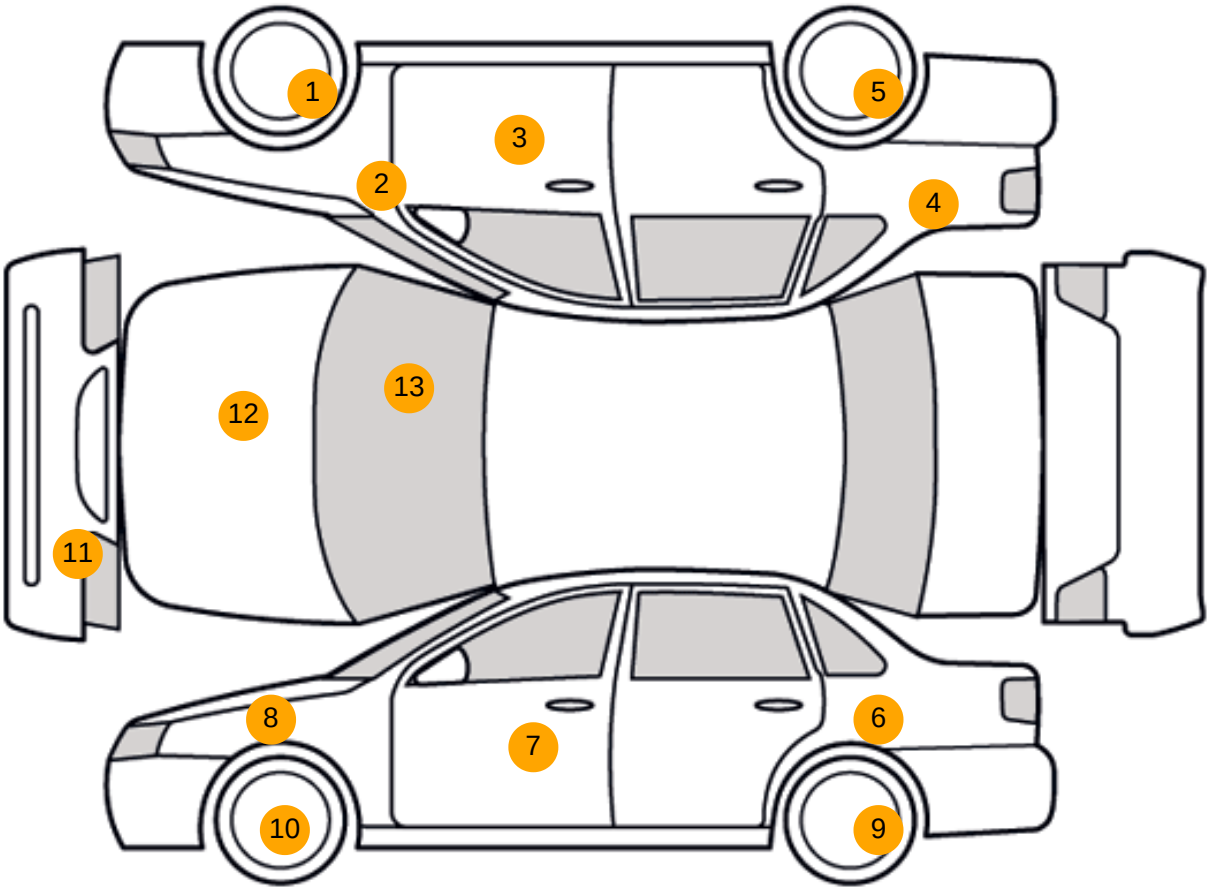
1: Wheel osf
Scratched
Over 50mm

2: Wing osf
Chipped
1 To 5

3: Door osf
Poor Previous Repair
Poor Paint

4: Qtr Panel osr
Poor Previous Repair
Paint Flake

8: Wing nsf
Poor Previous Repair
Paint Flake

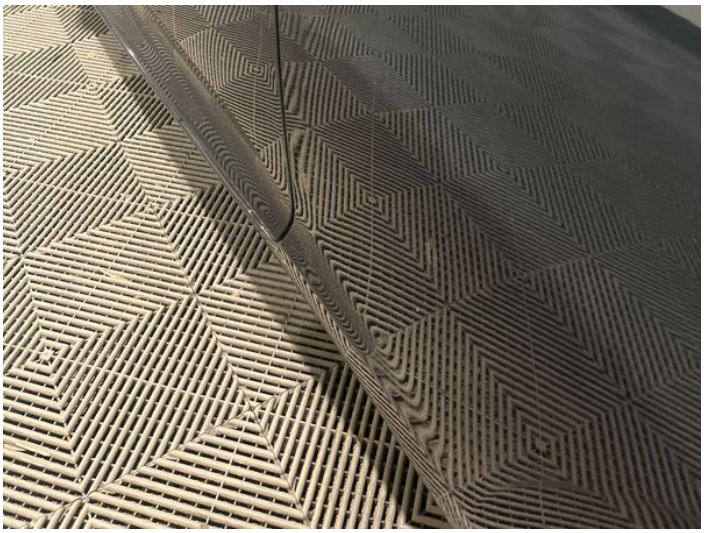
5: Wheel osr
Scratched
Over 50mm

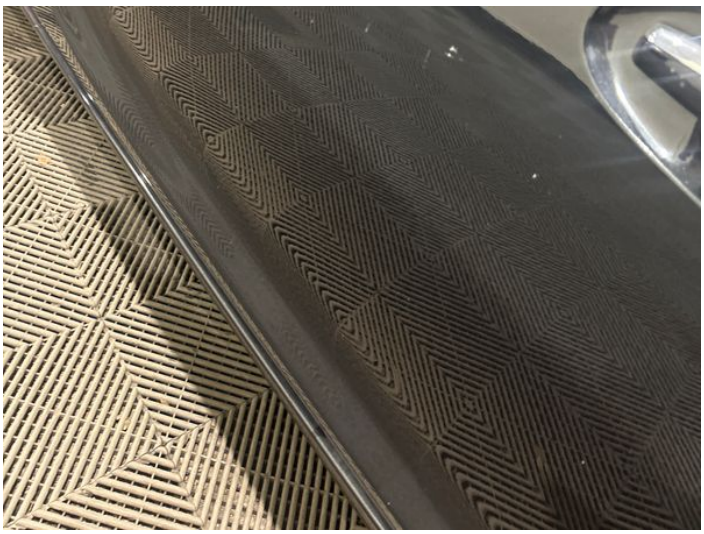
7: Door nsf
Chipped
Multiple Chips
