VEHICLE INSPECTION REPORT

MT15HNZ

Nissan Juke 1.2 DiG-T Tekna 5dr

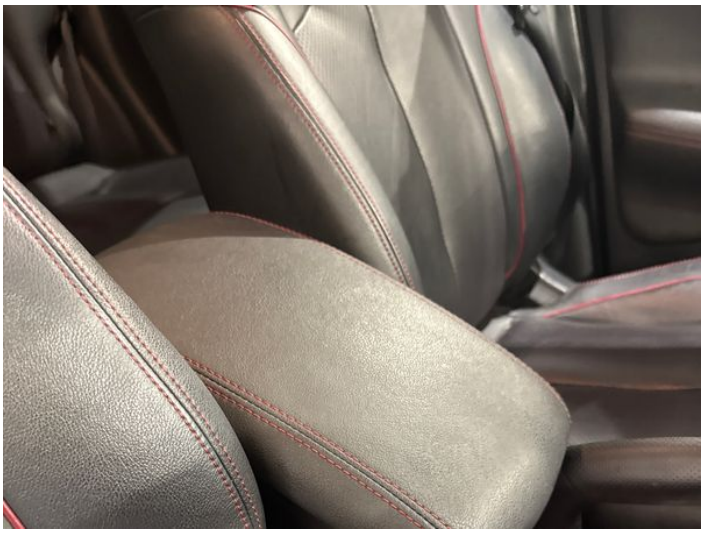
Damage Photos

1: Other
N/A
N/A
Arm rest damaged

2: Bonnet
Dented
With Paint Damage

3: Bumper Front
Scratched
25 to 100mm Thru Paint

4: Other
N/A
N/A
Trim scratched

5: Wheel nsf
Scratched
Over 50mm

6: Wing nsf
Chipped
1 To 5

7: Headlamp ns
Broken
Replace

8: A Post ns
Chipped
1 To 5

9: Door nsf
Dented
Over 30mm

10: Door nsr
Scratched
Over 25mm Thru Paint

11: Wheel nsr
Scratched
Over 50mm

12: Other
N/A
N/A
Rear lamp scratched

13: Bumper Rear
Scratched
Over 100mm Thru Paint

14: Qtr Panel osr
Scratched
UpTo 25mm Thru Paint

15: Wheel osr
Scratched
Over 50mm

16: Door osr
Chipped
1 To 5

17: Door osf
Scratched
Over 25mm Thru Paint

18: Wing osf
Chipped
1 To 5

19: Wheel osf
Scratched
Over 50mm

20: Aperture Seal osf
Broken
Replace

21: Roof
Rusted
Over 5mm

22: A Post os
Chipped
1 To 5
