VEHICLE INSPECTION REPORT

EF14WVK

BMW X1 sDrive 20d xLine 5dr

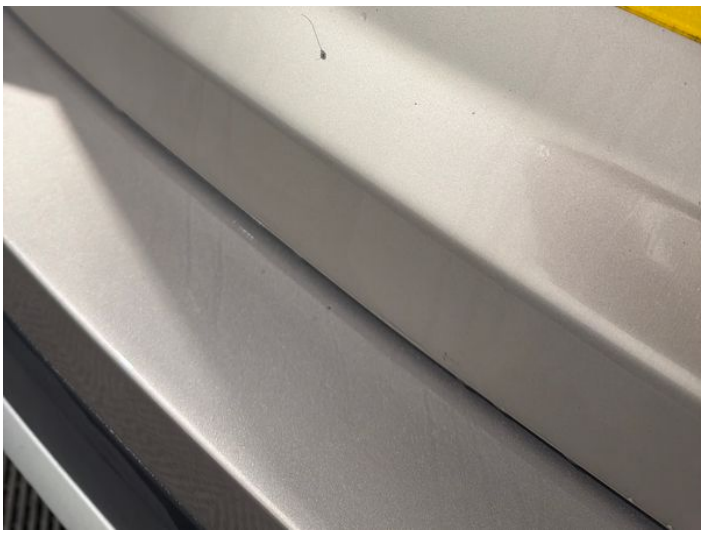
Damage Photos

1: Seat Base Cover osf
Scuffed
Over 25mm

2: Tyre nsf
Damaged
Replace

3: Bonnet
Chipped
1 To 5

4: Bumper Front
Chipped
1 To 5

5: Other
N/A
N/A
Headlight clouded

6: Wheel nsf
Scratched
Over 50mm

7: Screen Front
Chipped
UpTo 10mm

8: Door nsf
Chipped
1 To 5

9: Door nsf
Dented
Between 10mm + 30mm

10: Door nsr
Dented
Over 30mm

11: Door nsr
Chipped
1 To 5

12: Wheel nsr
Scratched
Over 50mm

13: Qtr Panel nsr
Chipped
1 To 5

14: Boot Lid
Scratched
UpTo 25mm Thru Paint

15: Roof
Dented
Over 30mm

16: Qtr Panel osr
Dented
Over 2 UpTo 10mm

17: Wheel osr
Scratched
Over 50mm

18: Door osr
Dented
With Paint Damage

19: Door osf
Chipped
Edge Chip

20: Wing osf
Dented
Between 10mm + 30mm

21: Wheel osf
Scratched
Over 50mm
