VEHICLE INSPECTION REPORT

AU14SXT

Ford Fiesta 1.0 EcoBoost Zetec 3dr

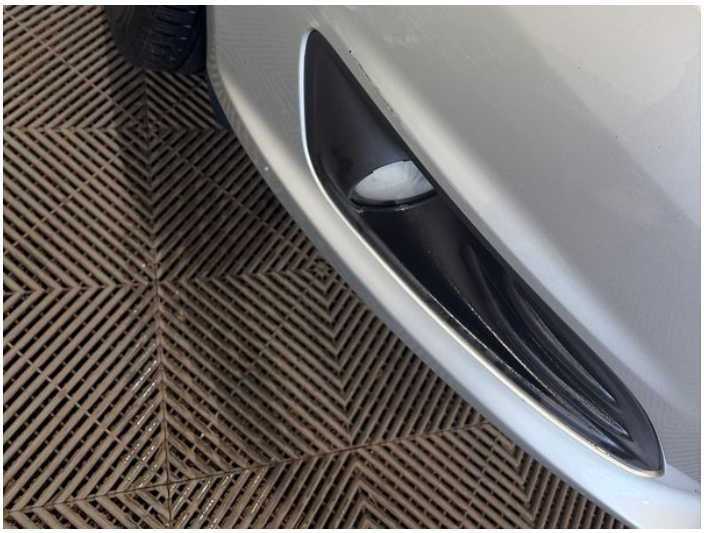
1: Wing osf
Dented
Over 30mm

2: Door osf
Dented
With Paint Damage

3: Qtr Panel osr
Scratched
Over 25mm Thru Paint

4: Bumper Rear
Scratched
25 to 100mm Thru Paint

5: Bumper Rear
Chipped
1 To 5

6: Qtr Panel nsr
Chipped
1 To 5

7: Door nsf
Chipped
1 To 5

8: Wing nsf
Chipped
1 To 5

9: Wheel nsf
Scratched
Over 50mm

10: Bonnet
Chipped
1 To 5

11: Bumper Front
Scratched
25 to 100mm Thru Paint

12: Bumper Front
Chipped
1 To 5

13: Screen Front
Chipped
UpTo 10mm
