VEHICLE INSPECTION REPORT

GX63LSV

Mitsubishi Shogun 3.2 DI-DC [197] SG3 5dr Auto

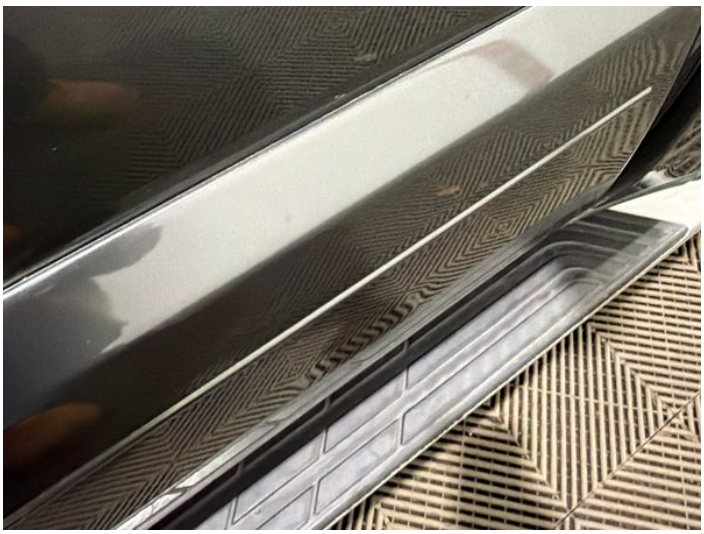
4: Bumper Front
Chipped
1 To 5

5: Wing nsf
Chipped
1 To 5

6: Screen Front
Cracked
Replace

7: Door nsf
Chipped
1 To 5

8: Door nsr
Chipped
1 To 5

9: Bumper Rear
Scratched
25 to 100mm Thru Paint
