VEHICLE INSPECTION REPORT

DK18XRG

Volkswagen Golf 2.0 TSI GTI 3dr DSG

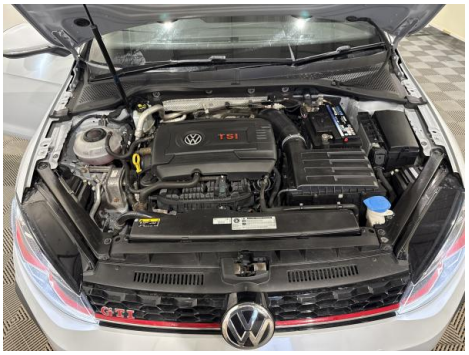
Last service 07/10/2022 at 50916 miles (4 main dealer services). Car cuts out when idling
Intermittent EML light car has been plugged in but shows no codes

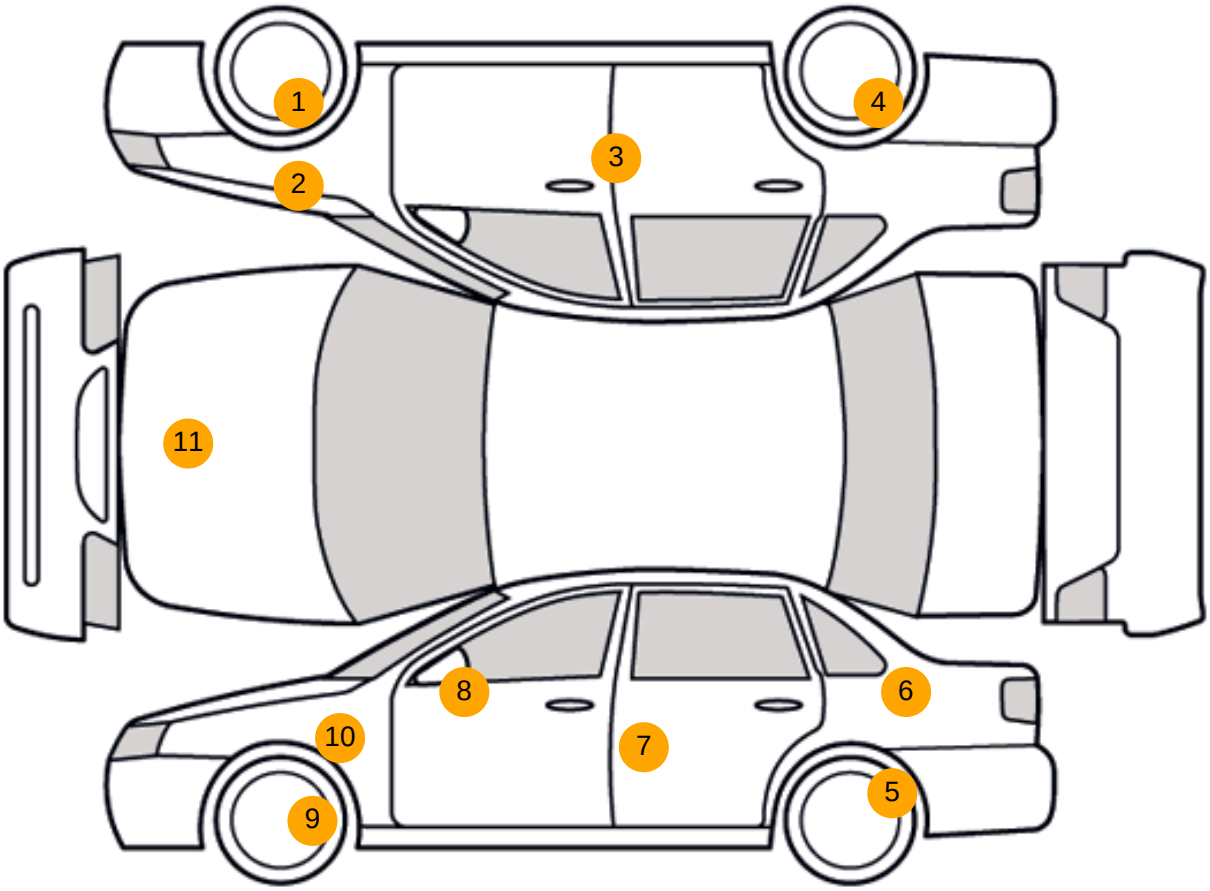
1: Wheel osf
Scratched
Up To 50mm

2: Wing osf
Chipped
1 To 5

3: Door osf
Chipped
Edge Chip

4: Wheel osr
Scratched
Over 50mm

5: Wheel nsr
Scratched
Up To 50mm

6: Qtr Panel nsr
Scratched
Over 25mm Not Thru Paint

7: Door nsf
Chipped
Edge Chip

8: Door Mirror Assy nsf
Scratched (Painted)
Over 25mm Not Thru Paint

9: Wheel nsf
Damaged
Replace

10: Wing nsf
Chipped
1 To 5

11: Bonnet
Chipped
1 To 5
