VEHICLE INSPECTION REPORT

LF69XNM

Mini Hatchback 1.5 Cooper Sport II 3dr

nama GRADE 2

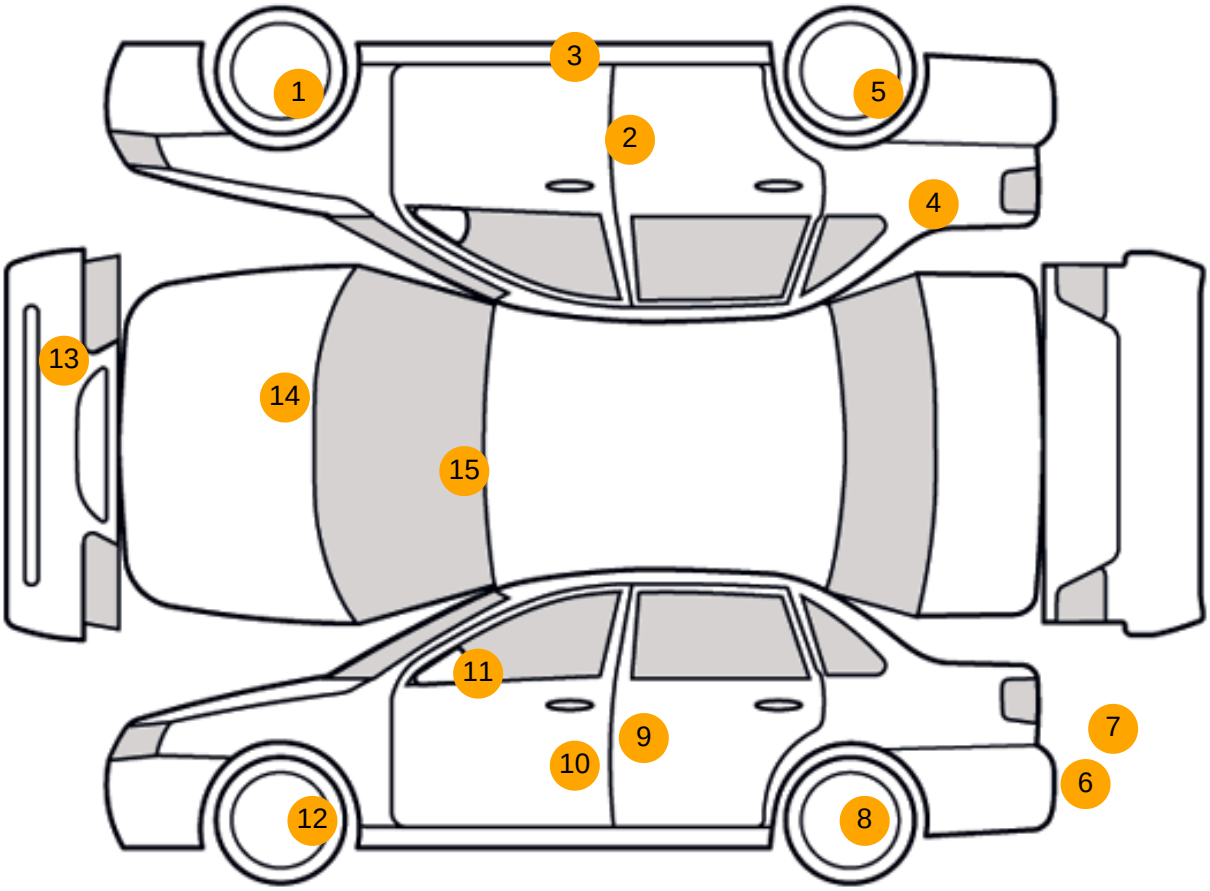
Condition Check

1: Wheel osf
Scratched
Over 50mm

2: Door osf
Chipped
Edge Chip

3: Sill Panel Trim os
Scratched (Painted)
UpTo 25mm Thru Paint

5: Wheel osr
Scratched
Over 50mm

6: Bumper Rear
Scratched
Over 25mm Not Thru Paint

7: Bumper Rear
Chipped
1 To 5

8: Wheel nsr
Scratched
Over 50mm

9: Door nsf
Chipped
Edge Chip

10: Door nsf
Scratched
Over 25mm Not Thru Paint

11: Door Mirror Assy nsf
Scratched (Painted)
Over 25mm Not Thru Paint

12: Wheel nsf
Scratched
Over 50mm

13: Bumper Front
Scratched
25 to 100mm Thru Paint

14: Bonnet
Chipped
1 To 5

15: Screen Front
Cracked
Replace
