VEHICLE INSPECTION REPORT

RE16VXN

Volkswagen Sharan 1.4 TSI BlueMotion Tech S 5dr

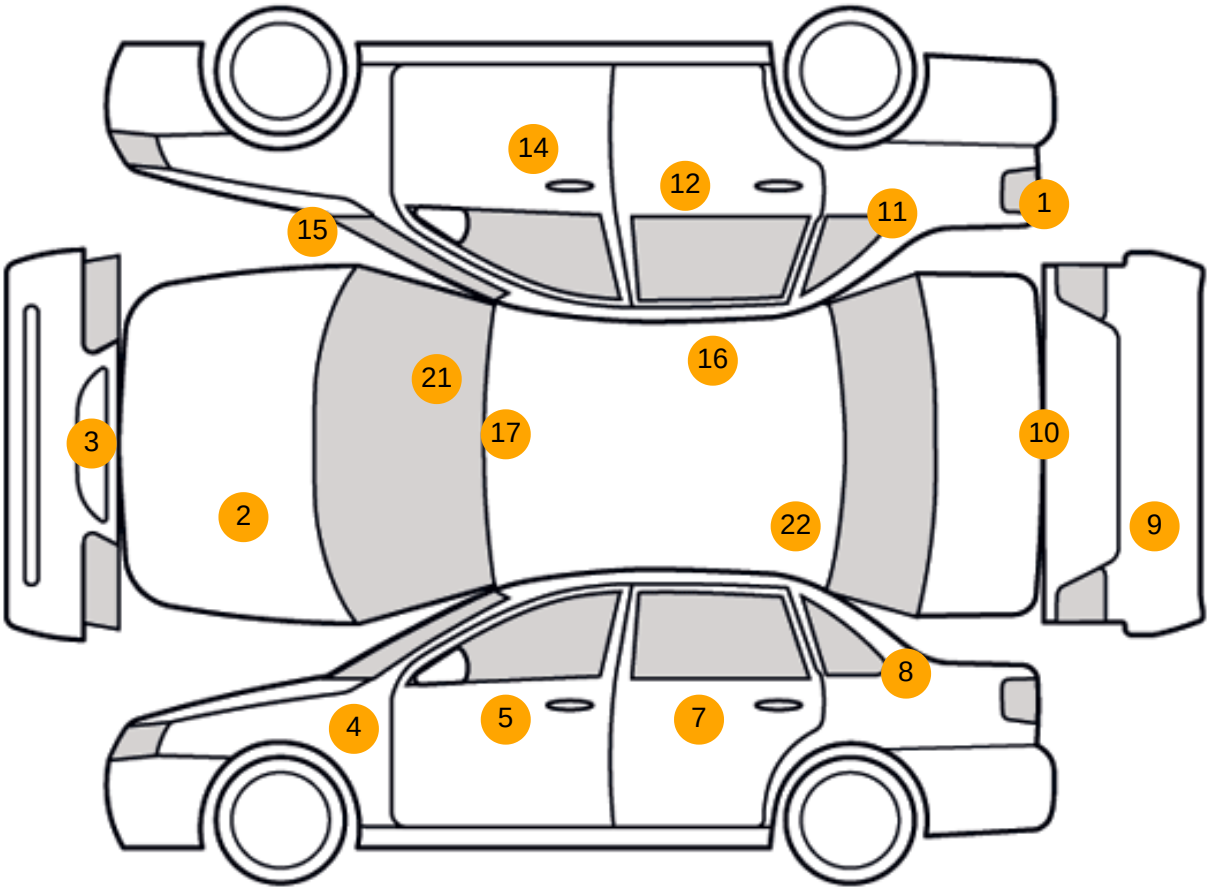
Condition Check

1: Lamp osr
Broken
Replace

2: Bonnet
Chipped
Multiple Chips

3: Bumper Front
Chipped
Multiple Chips

4: Wing nsf
Scratched
UpTo 25mm Thru Paint

5: Door nsf
Dented
Between 10mm + 30mm

6: Door nsf
Scratched
Over 25mm Thru Paint

7: Door nsr
Scratched
UpTo 25mm Thru Paint

8: Qtr Panel nsr
Scratched
UpTo 25mm Thru Paint

9: Bumper Rear
Cracked
UpTo 25mm

10: Tailgate
Dented
With Paint Damage

11: Qtr Panel osr
Scratched
UpTo 25mm Thru Paint

12: Door osr
Dented
Between 10mm + 30mm

13: Door osr
Scratched
Over 25mm Thru Paint

14: Door osf
Scratched
Over 25mm Thru Paint

15: Wing osf
Scratched
UpTo 25mm Thru Paint

16: B Post os
Dented
Between 10mm + 30mm

17: Roof
Scratched
Rusted

18: Sunvisor ns
Broken
Replace

19: Fascia Trim
Damaged
Replace

20: Fascia Trim
Damaged
Replace

21: Screen Front
Cracked
Replace

22: Roof
Dented
Over 30mm
