# VEHICLE INSPECTION REPORT

**BK13JXN**

## Honda Civic 1.8 i-VTEC EX 5dr

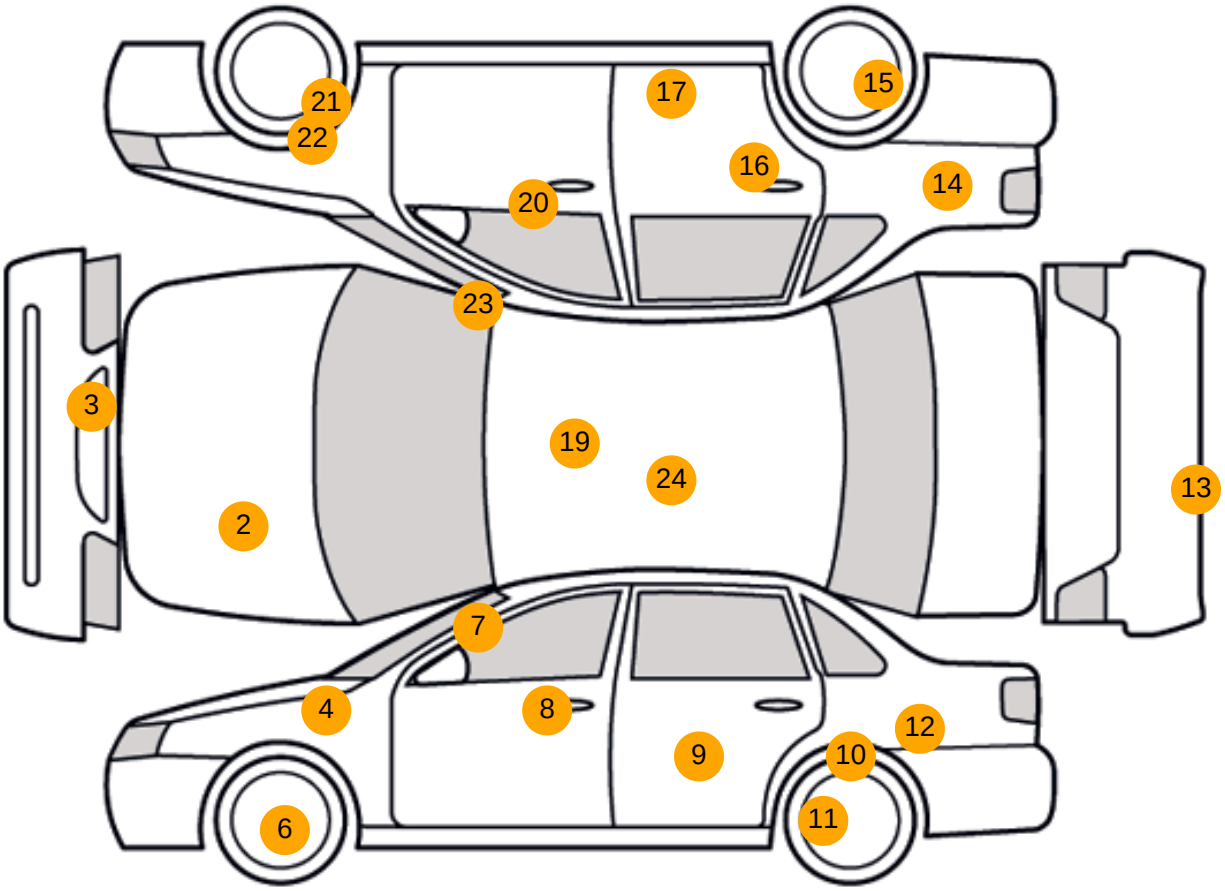
## Condition Check

1: Seat Base Cover osf
Scuffed
Over 25mm

2: Bonnet
Chipped
Multiple Chips

3: Bumper Front
Scratched
Over 100mm Thru Paint

4: Wing nsf
Dented
With Paint Damage

5: Bumper Front
Insecure
Action Required

6: Wheel nsf
Corroded
Light

7: A Post ns
Scratched
Over 25mm Thru Paint

8: Door nsf
Scratched
Over 25mm Thru Paint

9: Door nsr
Dented
With Paint Damage

10: Qtr Panel Arch Extension ns
Scuffed (Unpainted)
Over 100mm

11: Wheel nsr
Corroded
Light

12: Qtr Panel nsr
Chipped
1 To 5

13: Bumper Rear
Scratched
25 to 100mm Thru Paint

14: Qtr Panel osr
Dented
With Paint Damage

15: Wheel osr
Corroded
Light

16: Door osr
Dented
Between 10mm + 30mm

17: Aperture Seal osr
Broken
Replace

18: Door osr
Scratched
Over 25mm Thru Paint

19: Roof
Scratched
Rusted

20: Door osf
Scratched
Over 25mm Thru Paint

21: Wheel osf
Corroded
Light

22: Wing osf
Chipped
1 To 5

23: A Post os
Scratched
Over 25mm Thru Paint

24: Roof
Dented
Over 30mm

25: Switches And Controls
Broken
Replace

26: Carpets Front
Scuffed
Over 25mm
