VEHICLE INSPECTION REPORT

VX69SHZ

Porsche Macan S 5dr PDK

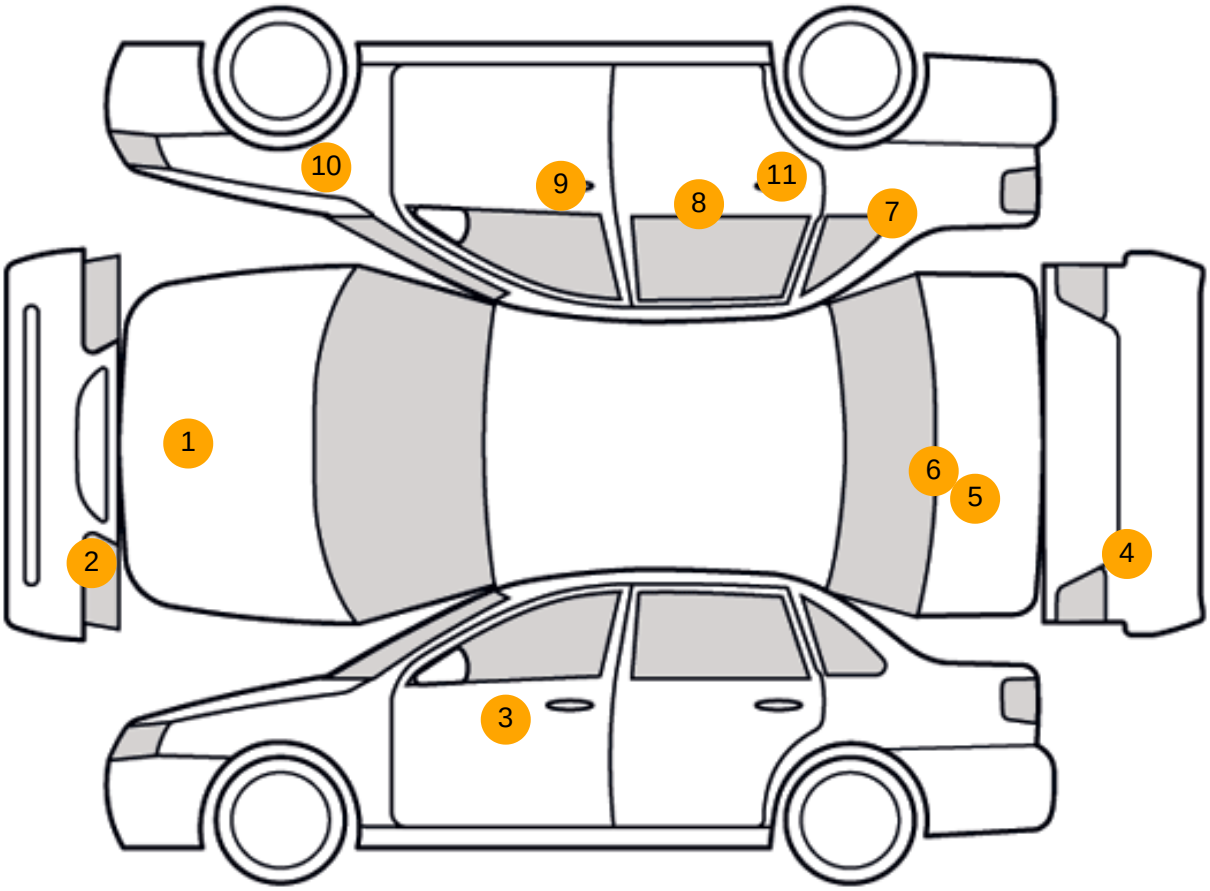
Condition Check

1: Bonnet
Chipped
1 To 5

2: Bumper Front
Scratched
UpTo 25mm Thru Paint

3: Door nsf
Scratched
UpTo 25mm Thru Paint

4: Bumper Rear
Scratched
Up To 25mm Thru Paint

5: Bumper Rear
Scratched
25 to 100mm Thru Paint

6: Tailgate
Scratched
UpTo 25mm Thru Paint

7: Qtr Panel osr
Scratched
Over 25mm Thru Paint

8: Door osr
Scratched
UpTo 25mm Not Thru Paint

9: Door osf
Scratched
UpTo 25mm Thru Paint

10: Wing osf
Scratched
UpTo 25mm Thru Paint

11: Door osr
Dented
Over 2 UpTo 10mm
