VEHICLE INSPECTION REPORT

LD72OCU

Vauxhall Grandland 1.2 Turbo Ultimate 5dr

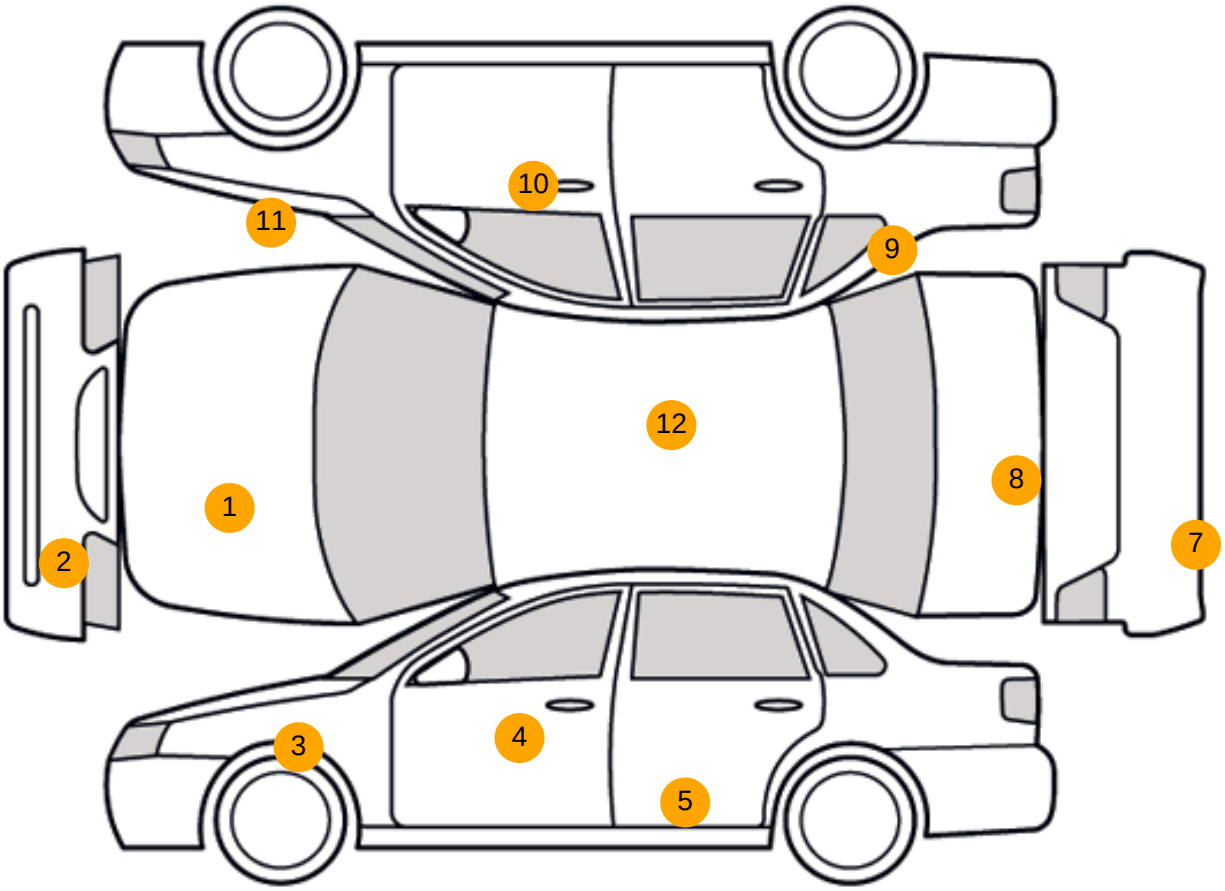
Condition Check

1: Bonnet
Chipped
1 To 5

2: Bumper Front
Poor Previous Repair
Rippled UpTo 30%

3: Wing nsf
Poor Previous Repair
Poor Paint

4: Door nsf
Dented
Between 10mm + 30mm

5: Door nsr
Dented
Between 10mm + 30mm

6: Door nsf
Poor Previous Repair
Poor Paint

7: Bumper Rear
Scratched
25 to 100mm Thru Paint

8: Tailgate
Scratched
Over 25mm Thru Paint

9: Door osr
Dented
Between 10mm + 30mm

10: Door osf
Scratched
Over 25mm Thru Paint

11: Wing osf
Scratched
UpTo 25mm Thru Paint

12: Roof
Scratched
Over 25mm Thru Paint

13: Tyre osr
Damaged
Replace
