VEHICLE INSPECTION REPORT

BK62OYY

Seat Alhambra 2.0 TDI CR Ecomotive SE 5dr

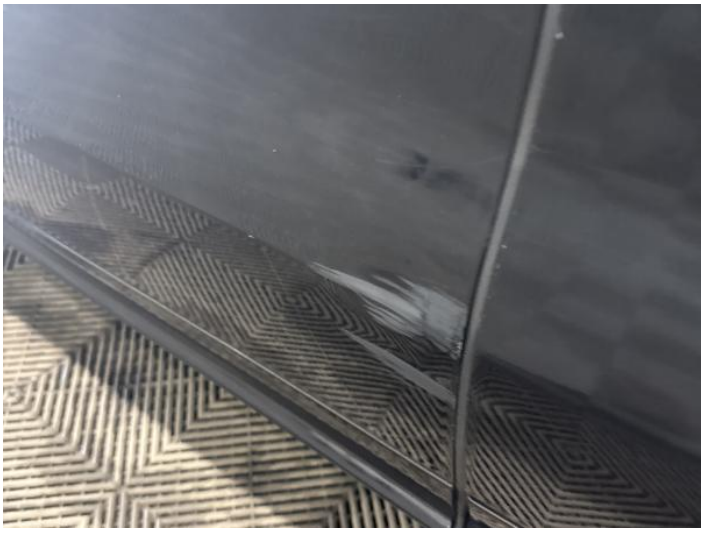
Damage Photos

1: Bonnet
Chipped
Multiple Chips

2: Bumper Front
Scratched
Over 100mm Thru Paint

3: Wing nsf
Scratched
Over 25mm Thru Paint

4: Wheel nsf
Scratched
Over 50mm

5: Door Mirror Assy nsf
Scratched (Painted)
Over 25mm Thru Paint

6: A Post ns
Chipped
1 To 5

7: Door nsf
Dented
With Paint Damage

8: Door nsr
Scratched
Over 25mm Thru Paint

9: Wheel nsr
Scratched
Over 50mm

10: Qtr Panel nsr
Scratched
Over 25mm Thru Paint

11: Bumper Rear
Poor Previous Repair
Paint Flake

12: Tailgate
Rusted
Over 5mm

13: Lamp osr
Broken
Replace

14: Qtr Panel osr
Rusted
Over 5mm

15: Wheel osr
Scratched
Over 50mm

16: Door osr
Poor Previous Repair
Poor Paint

17: Door osf
Chipped
1 To 5

18: Wing osf
Chipped
1 To 5

19: Wheel osf
Scratched
Up To 50mm

20: A Post os
Dented
Over 2 UpTo 10mm

21: B Post ns
Dented
Between 10mm + 30mm

22: Roof
Chipped
Multiple Chips
