VEHICLE INSPECTION REPORT

FD61HHW

Toyota Avensis 1.8 V-matic TR 5dr

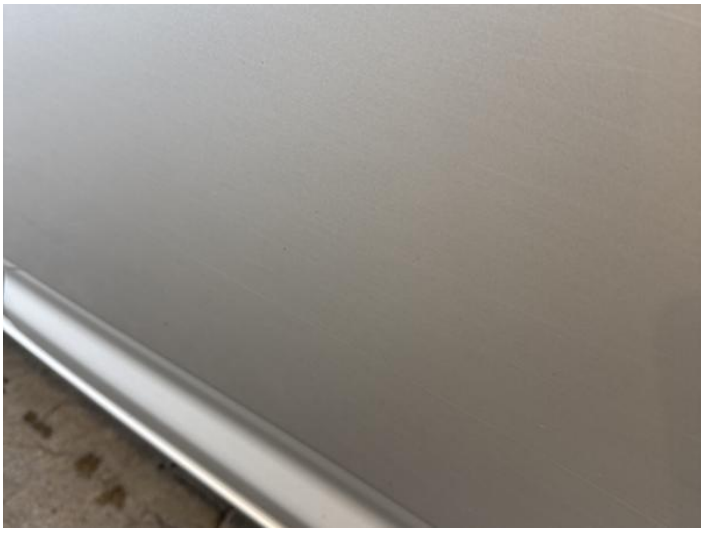
1: Bonnet
Chipped
Multiple Chips

2: Bumper Front
Dented
With Paint Damage

3: Wheel nsf
Scratched
Over 50mm

4: Wing nsf
Scratched
Over 25mm Thru Paint

5: Door Mirror Assy nsf
Scratched (Painted)
UpTo 25mm Thru Paint

6: Door nsf
Scratched
Over 25mm Thru Paint

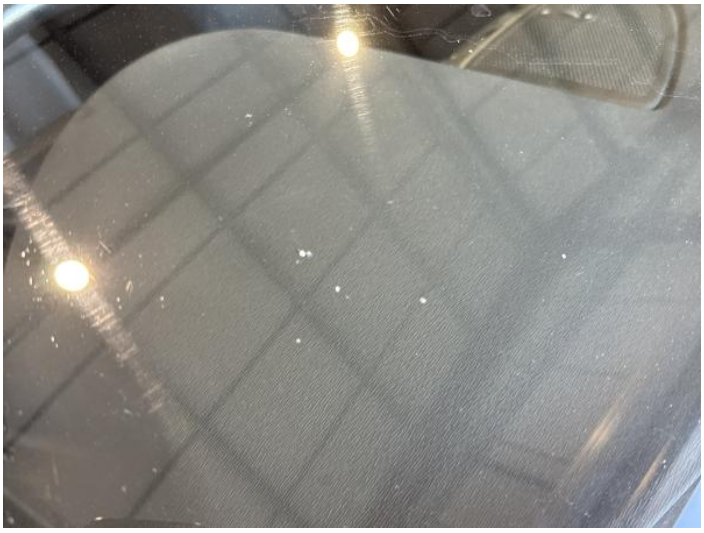
7: Door nsr
Scratched
Over 25mm Thru Paint

8: Wheel nsr
Scratched
Over 50mm

9: Qtr Panel nsr
Dented
With Paint Damage

10: Bumper Rear
Dented
With Paint Damage

11: Tailgate
Chipped
1 To 5

12: Qtr Panel osr
Dented
Between 10mm + 30mm

13: Qtr Panel osr
Scratched
Over 25mm Thru Paint

14: Wheel osr
Scratched
Over 50mm

15: Door osr
Scratched
Over 25mm Thru Paint

16: Door osf
Scratched
Over 25mm Thru Paint

17: Door Mirror Assy osf
Scratched (Painted)
Over 25mm Thru Paint

18: Wing osf
Chipped
Multiple Chips

19: Wheel osf
Scratched
Over 50mm
