VEHICLE INSPECTION REPORT

EA18HNW

Renault Captur 0.9 TCE 90 Dynamique Nav 5dr

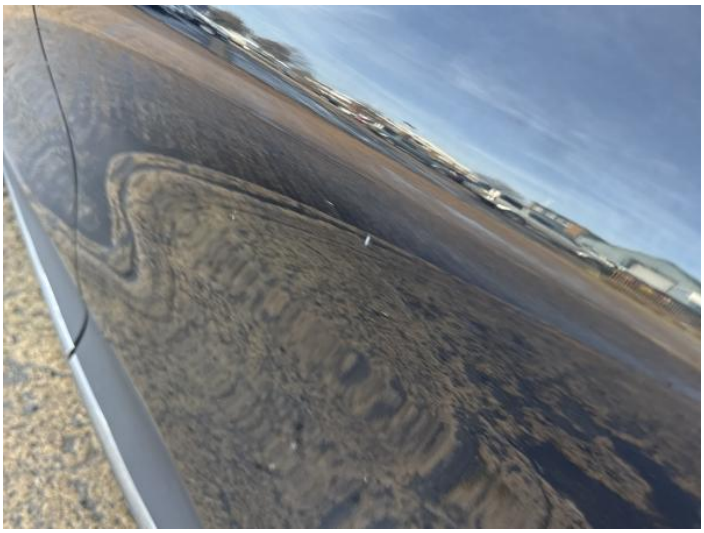
Damage Photos

1: Bonnet
Chipped
Multiple Chips

2: Bumper Front
Poor Previous Repair
Paint Flake

3: Wing Front Arch Extension os
Scuffed (Unpainted)
UpTo 100mm

4: Wing osf
Scratched
Over 25mm Thru Paint

5: Wheel osf
Scratched
Over 50mm

6: Door Mirror Assy osf
Scratched (Painted)
UpTo 25mm Thru Paint

7: Door osf
Dented
With Paint Damage

8: Door osr
Dented
With Paint Damage

9: Wheel osr
Scratched
Over 50mm

10: Qtr Panel osr
Dented
Between 10mm + 30mm

11: Qtr Panel osr
Scratched
Over 25mm Thru Paint

12: Bumper Rear Moulding
Scuffed (Unpainted)
Over 100mm

13: Bumper Rear
Scratched
25 to 100mm Thru Paint

14: Tailgate
Scratched
Over 25mm Thru Paint

15: Qtr Panel nsr
Dented
Between 10mm + 30mm

16: Qtr Panel osr
Scratched
Over 25mm Thru Paint

17: Wheel nsr
Scratched
Over 50mm

18: Door nsr
Chipped
1 To 5

19: Door nsf
Dented
With Paint Damage

20: Wing osf
Scratched
UpTo 25mm Thru Paint

21: Wheel osf
Scratched
Over 50mm
