# VEHICLE INSPECTION REPORT

**KM64VTD**

## Volkswagen Golf 2.0 TDI Match 5dr DSG

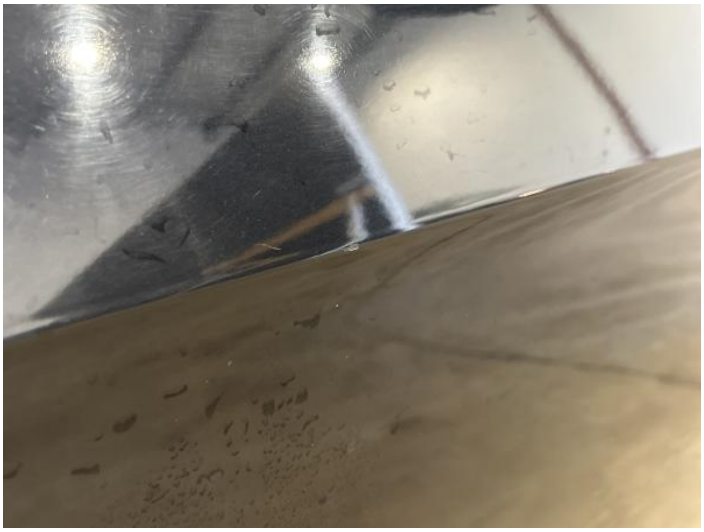
1: Wheel osf
Scratched
Over 50mm

2: Wing osf
Chipped
1 To 5
