VEHICLE INSPECTION REPORT

DT18OZN

Vauxhall Astra 1.6 CDTi 16V ecoTEC Tech Line Nav 5dr

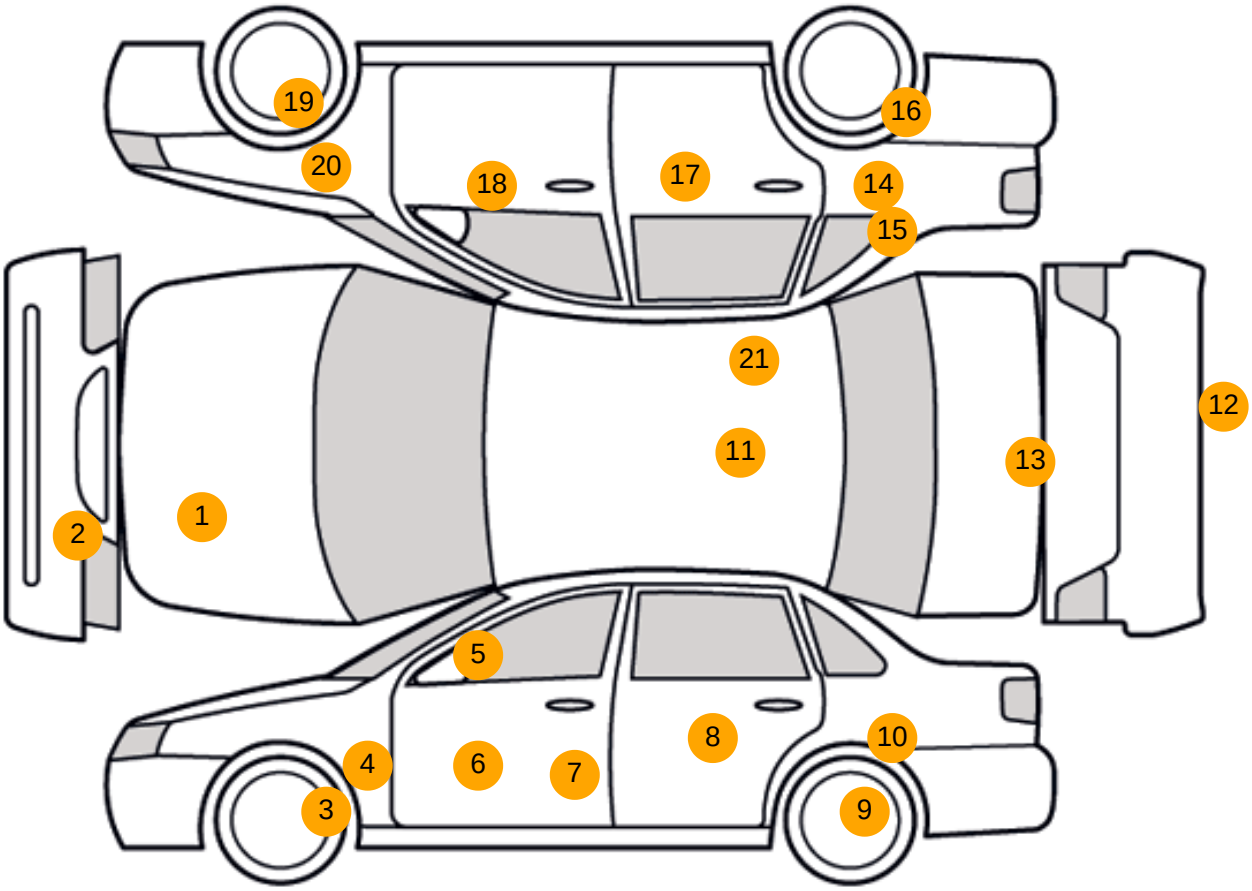
Condition Check

1: Bonnet
Dented
Over 30mm

2: Bumper Front
Scratched
UpTo 25mm Thru Paint

3: Wheel nsf
Scratched
Over 50mm

4: Wing nsf
Scratched
Over 25mm Thru Paint

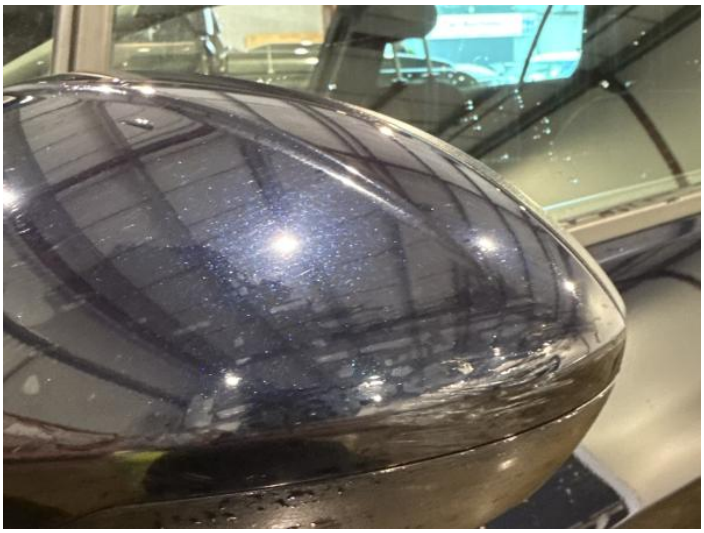
5: Door Mirror Assy nsf
Scratched (Painted)
Over 25mm Thru Paint

6: Door nsf
Scratched
Over 25mm Thru Paint

7: Door nsf
Dented
Between 10mm + 30mm

8: Door nsr
Chipped
Multiple Chips

9: Wheel nsr
Scratched
Over 50mm

10: Qtr Panel nsr
Scratched
Over 25mm Thru Paint

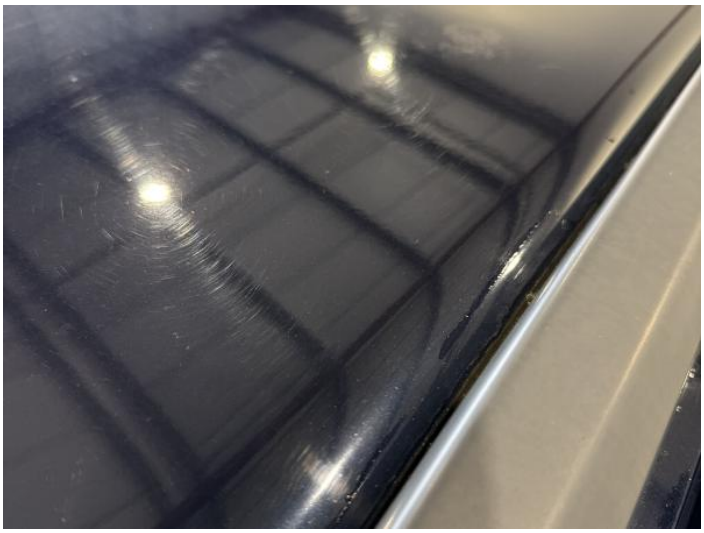
11: Roof
Dented
Over 30mm

12: Bumper Rear
Scratched
25 to 100mm Thru Paint

13: Tailgate
Scratched
UpTo 25mm Thru Paint

14: Qtr Panel osr
Dented
Between 10mm + 30mm

15: Qtr Panel osr
Scratched
Over 25mm Thru Paint

16: Wheel osr
Corroded
Light

17: Door osr
Poor Previous Repair
Rippled UpTo 30%

18: Door osf
Dented
With Paint Damage

19: Wheel osf
Scratched
Over 50mm

20: Wing osf
Chipped
1 To 5

21: B Post os
Scratched
Over 25mm Thru Paint
