VEHICLE INSPECTION REPORT

EO13YPA

Mercedes-Benz A Class A200 BlueEFFICIENCY Sport 5dr Auto

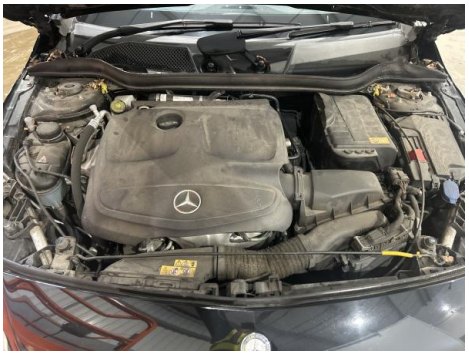
8787.3
miles
59346
13.0°C

No navigation module is connected.

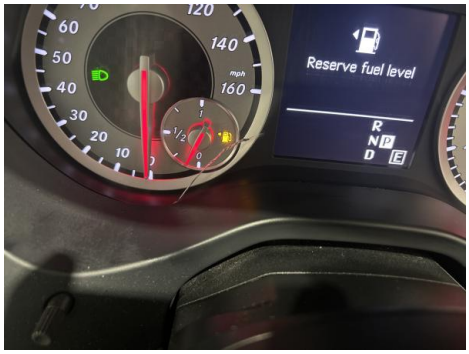
Reserve fuel level

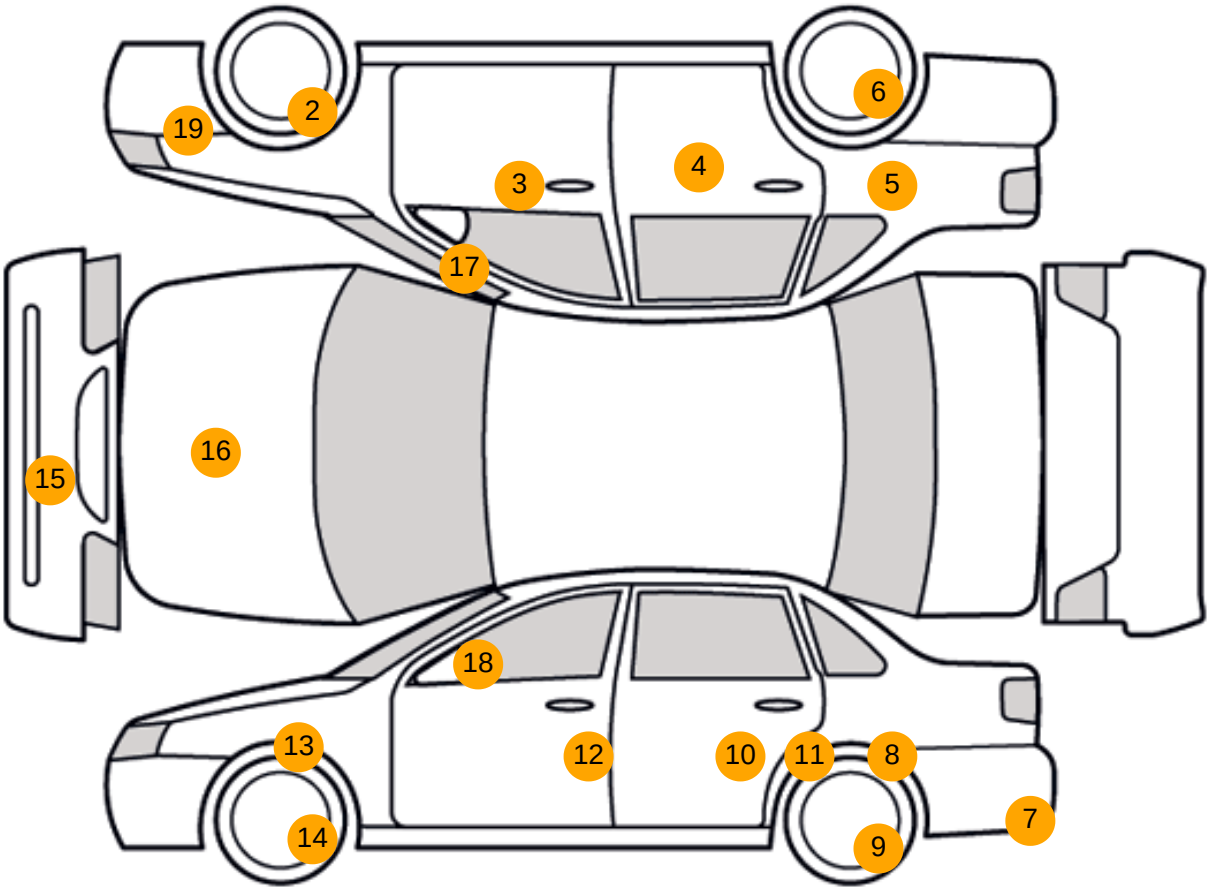
Condition Check

1: Other
N/A
N/A

2: Wheel osf
Corroded
Light

3: Door osf
Chipped
Multiple Chips

4: Door osr
Dented
With Paint Damage

5: Qtr Panel osr
Scratched
Over 25mm Thru Paint

6: Wheel osr
Corroded
Light

7: Bumper Rear
Scratched
Over 100mm Thru Paint

8: Qtr Panel nsr
Chipped
Over 5mm

9: Wheel nsr
Corroded
Light

10: Door nsr
Chipped
1 To 5

11: Door nsr
Chipped
Edge Chip

12: Door nsf
Dented
With Paint Damage

13: Wing nsf
Chipped
1 To 5

14: Wheel nsf
Corroded
Light

15: Bumper Front
Scratched
25 to 100mm Thru Paint

16: Bonnet
Chipped
Multiple Chips

17: A Post os
Chipped
1 To 5

18: A Post ns
Chipped
1 To 5

19: Bumper Front
Chipped
Multiple Chips
