VEHICLE INSPECTION REPORT

RO64CWL

Nissan Qashqai 1.2 DiG-T N-Tec+ 5dr Xtronic

nama GRADE 4

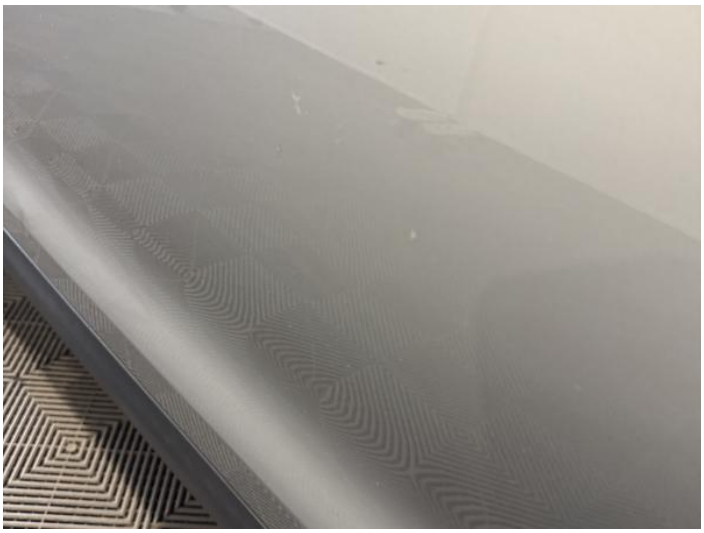
1: Bonnet
Chipped
1 To 5

2: Bumper Front
Scratched
25 to 100mm Thru Paint

3: Wing nsf
Dented
With Paint Damage

4: Wheel nsf
Scratched
Over 50mm

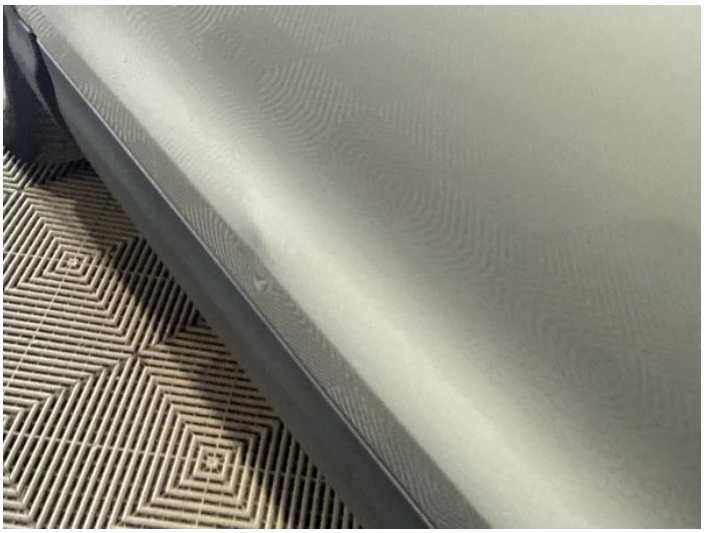
5: Door nsf
Chipped
Multiple Chips
