VEHICLE INSPECTION REPORT

GY61VUE

Audi Q3 2.0 TDI [177] Quattro SE 5dr S Tronic

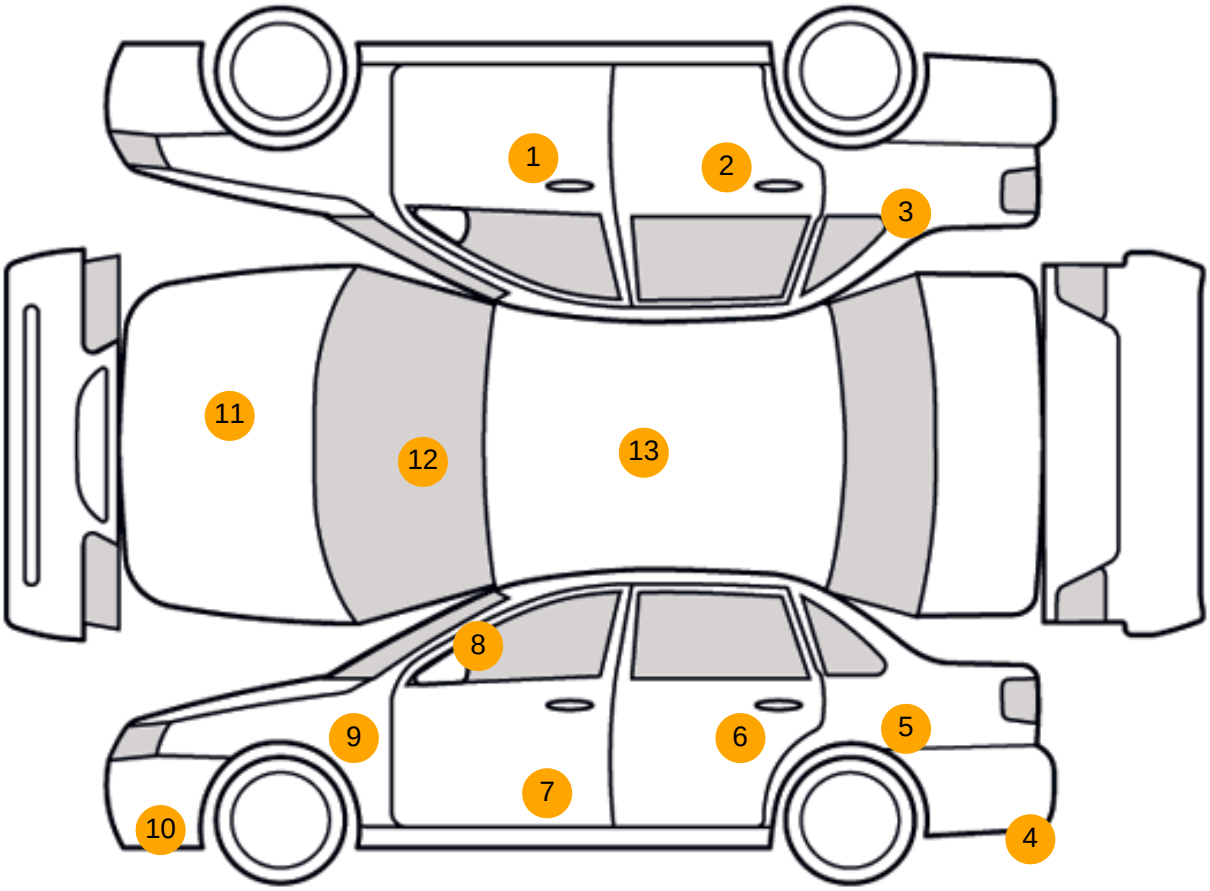
Condition Check

1: Door osf
Scratched
Over 25mm Thru Paint

2: Door osr
Scratched
Over 25mm Not Thru Paint

3: Qtr Panel osr
Scratched
Over 25mm Not Thru Paint

4: Bumper Rear
Scratched
Over 100mm Thru Paint

5: Qtr Panel nsr
Scratched
Over 25mm Not Thru Paint

6: Door nsr
Scratched
Over 25mm Not Thru Paint

7: Door nsf
Scratched
Over 25mm Not Thru Paint

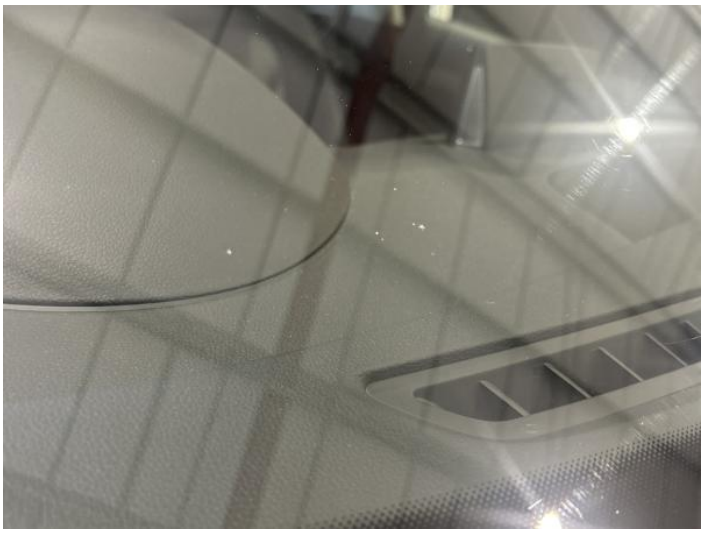
12: Screen Front
Chipped
UpTo 10mm

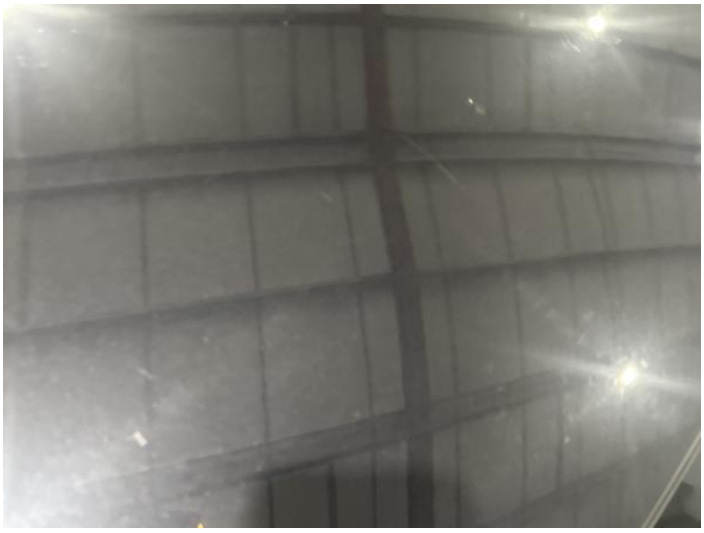
13: Roof
Scratched
Over 25mm Not Thru Paint
