VEHICLE INSPECTION REPORT

YP68UHK

Ford Ranger Pick Up Double Cab Wildtrak 3.2 TDCi 200 Auto

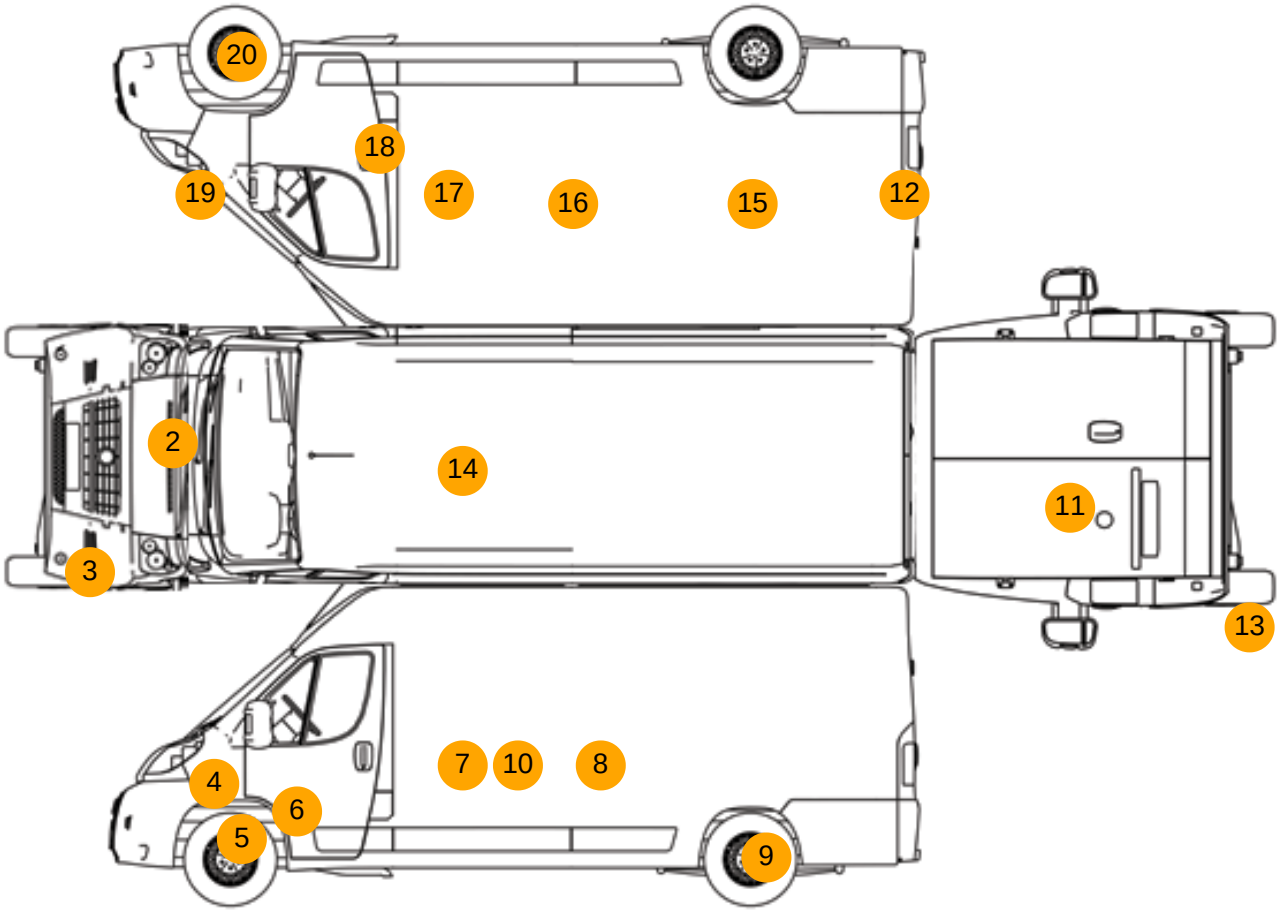
Damage Photos

1: Seat Back Cover osf
Scuffed
Over 25mm

2: Bonnet
Chipped
1 To 5

3: Bumper Front
Cracked
UpTo 25mm

4: Wing nsf
Poor Previous Repair
Poor Paint

5: Wheel nsf
Scratched
Over 50mm

6: Door nsf
Dented
With Paint Damage

7: Door nsr
Scratched
Over 25mm Thru Paint

8: Qtr Panel nsr
Chipped
Multiple Chips

9: Wheel nsr
Scratched
Up To 50mm

10: C Post ns
Chipped
1 To 5

11: Tailgate
Dented
Over 30mm

12: Qtr Panel osr
Rusted
Over 5mm

13: Bumper Rear
Scratched
25 to 100mm Thru Paint

14: Roof
Dented
Between 10mm + 30mm

15: Qtr Panel osr
Dented
Over 30mm

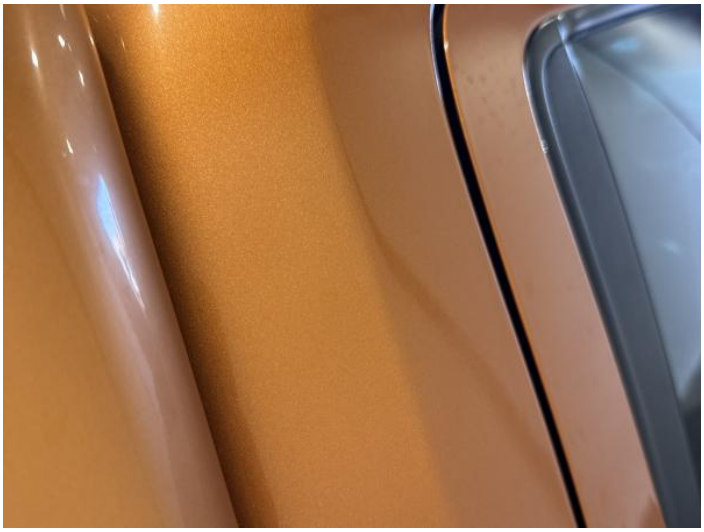
16: C Post os
Dented
Between 10mm + 30mm

17: Door osr
Chipped
1 To 5

18: Door osf
Dented
Between 10mm + 30mm

19: Wing osf
Chipped
1 To 5

20: Wheel osf
Scratched
Over 50mm
