VEHICLE INSPECTION REPORT

GX52NZM

Nissan Almera TWISTER

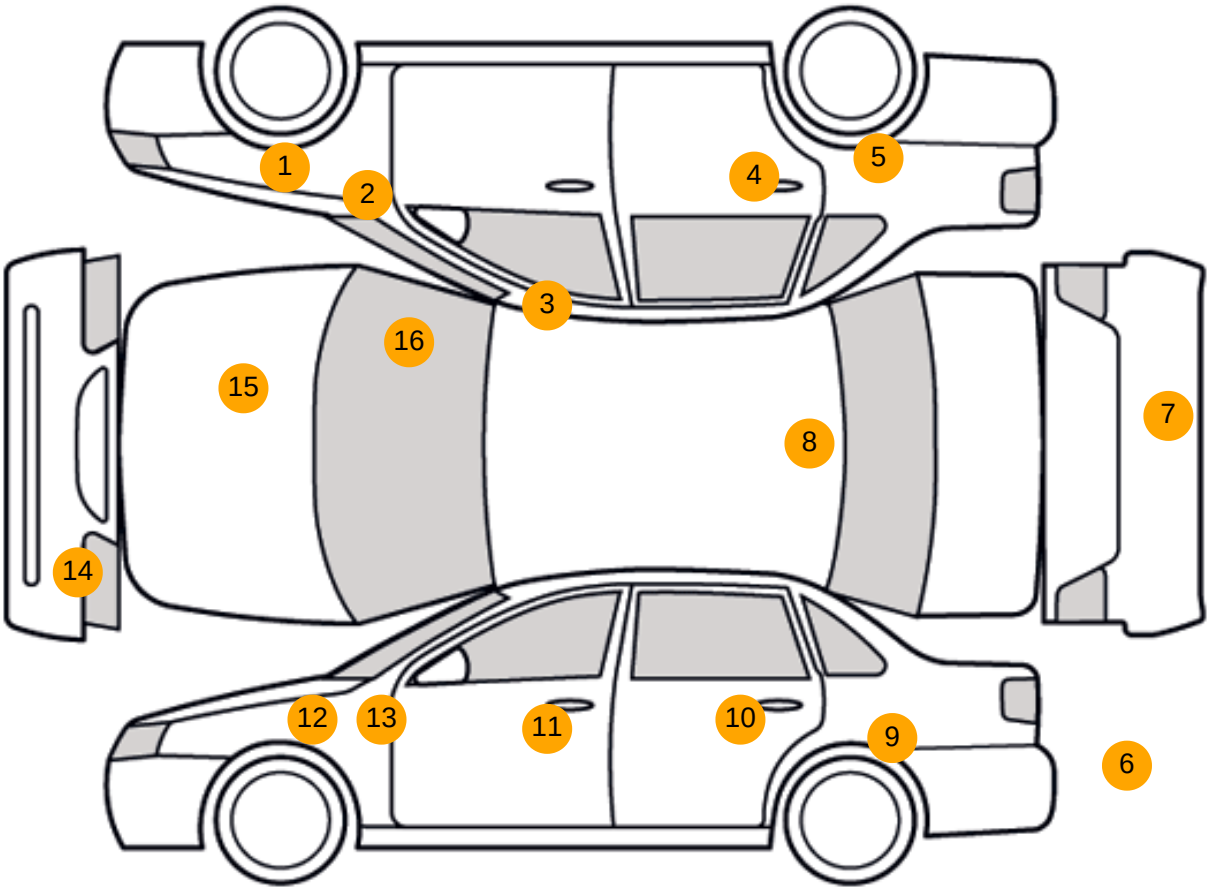
Condition Check

1: Wing osf
Chipped
1 To 5

2: Wing osf
Scratched
UpTo 25mm Thru Paint

3: Door osf
Rusted
Over 5mm

4: Door osr
Scratched
Over 25mm Thru Paint

5: Qtr Panel osr
Dented
With Paint Damage

6: Bumper Rear
Poor Previous Repair
Paint Flake

7: Tailgate
Rusted
Over 5mm

8: Roof
Rusted
Over 5mm

9: Qtr Panel nsr
Scratched
Over 25mm Thru Paint

10: Door nsr
Rusted
Over 5mm

11: Door nsf
Rusted
Over 5mm

12: Wing nsf
Chipped
1 To 5

13: Wing nsf
Scratched
Over 25mm Not Thru Paint

14: Bumper Front
Cracked
Over 25mm

15: Bonnet
Chipped
Multiple Chips

16: Screen Front
Cracked
Replace

17: Sunvisor ns
Missing
Replace
