VEHICLE INSPECTION REPORT

HG65JSZ

Smart Forfour 0.9 Turbo Prime Premium 5dr

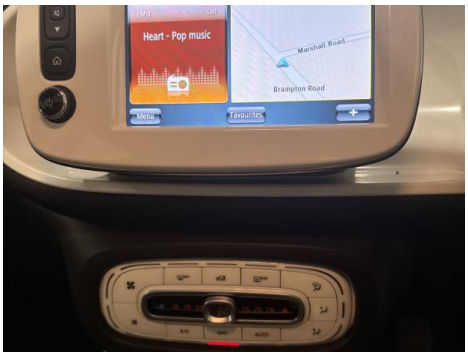
5:09 pm
0 km/h
10°C
5961.6
65152
miles

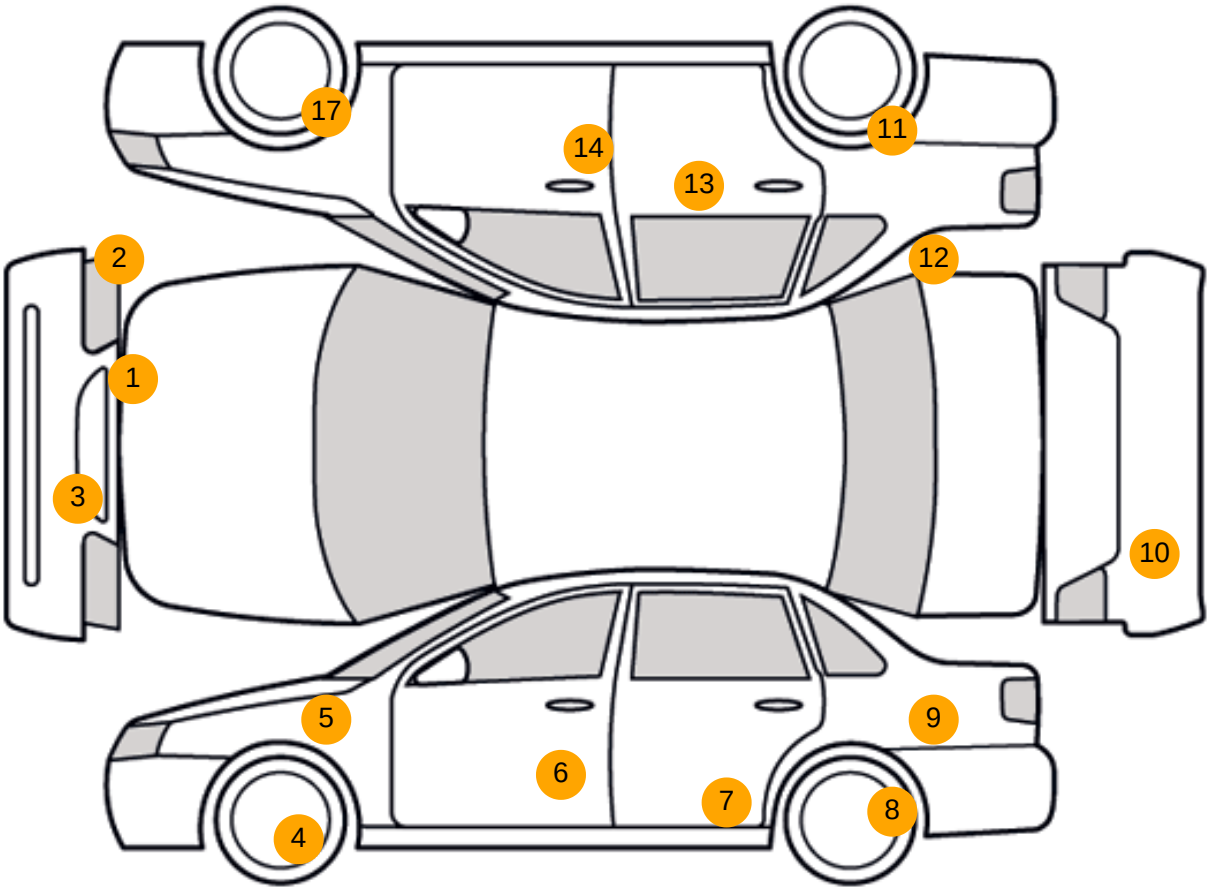
Condition Check

Bonnet and wing out of line

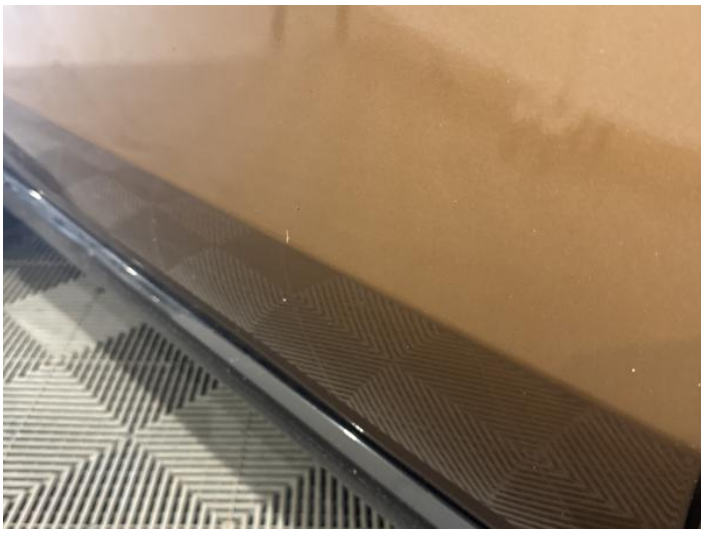
Damage Photos

1: Bumper Front
Insecure
Action Required

2: Headlamp os
Broken
Replace

3: Bumper Front
Scratched
25 to 100mm Thru Paint

4: Wheel nsf
Scratched
Over 50mm

5: Wing nsf
Chipped
1 To 5

6: Door nsf
Scratched
UpTo 25mm Thru Paint

7: Door osr
Scratched
UpTo 25mm Thru Paint

8: Wheel osr
Scratched
Over 50mm

9: Qtr Panel osr
Scratched
Over 25mm Thru Paint

10: Bumper Rear
Scratched
25 to 100mm Thru Paint

11: Wheel osr
Scratched
Up To 50mm

12: Qtr Panel osr
Scratched
UpTo 25mm Thru Paint

13: Door osr
Dented
Between 10mm + 30mm

14: Door osf
Dented
Over 30mm

15: Door osf
Chipped
Edge Chip

16: Door osf
Scratched
UpTo 25mm Thru Paint

17: Wheel osf
Scratched
Over 50mm
