VEHICLE INSPECTION REPORT

BF15UOH

Ford Transit 2.2 TDCi 125ps H2 Van

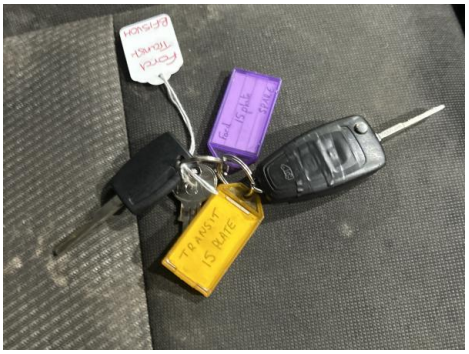
Ford
169710mls

12°C
Engine
Service now

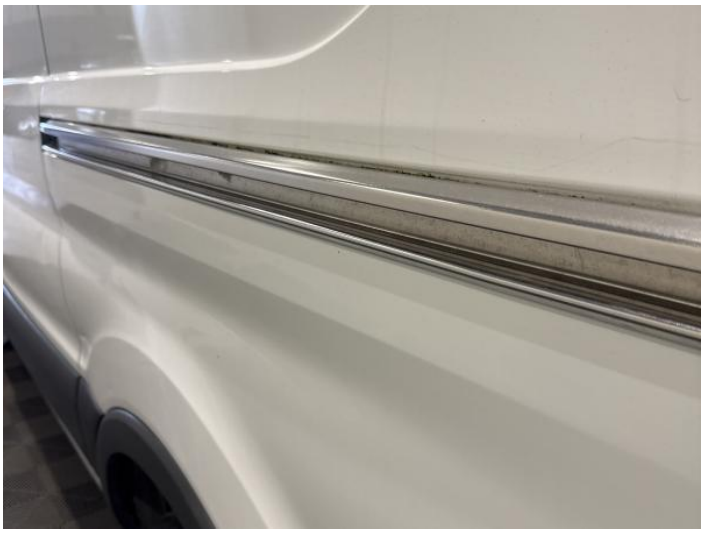
Damage Photos

1: Bonnet
Chipped
Multiple Chips

2: Bumper Front Moulding
Scuffed (Unpainted)
Over 100mm

3: Bumper Front
Insecure
Action Required

4: Bumper Front
Scratched
25 to 100mm Thru Paint

5: A Post ns
Dented
Over 30mm

6: Wing nsf
Chipped
1 To 5

7: Door nsf
Dented
With Paint Damage

8: Fuel Flap
Missing
Replace

9: Door nsr
Cracked
Replace

10: Sill Panel Trim ns
Missing
Replace

11: Qtr Panel nsr
Dented
Over 30mm

12: Tailgate
Dented
With Paint Damage

13: Qtr Panel osr
Dented
Between 10mm + 30mm

14: Qtr Panel Moulding os
Scuffed (Unpainted)
UpTo 100mm

15: Panel Front
Dented
Over 30mm

16: Door osf
Dented
Over 30mm

17: Wing osf
Scratched
Over 25mm Thru Paint

18: Wing Front Arch Extension os
Broken
Replace

19: Roof
Rusted
Over 5mm

20: Roof
Dented
With Paint Damage
