VEHICLE INSPECTION REPORT

AU23PFJ

Hyundai Tucson 1.6 TGDi Plug-in Hybrid Ultimate 5dr 4WD Auto

nama GRADE 2

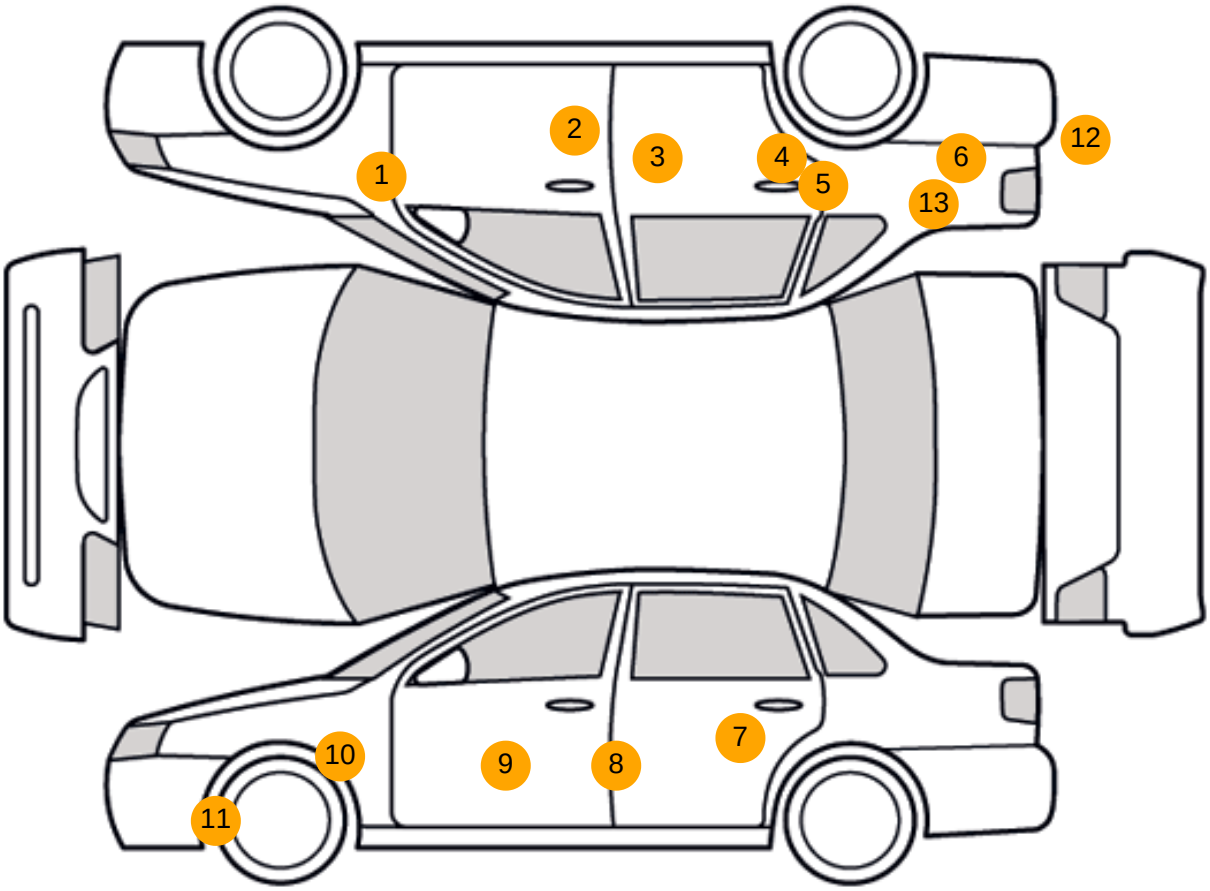
Condition Check

1: Wing osf
Scratched
Over 25mm Not Thru Paint

2: Door osf
Chipped
1 To 5

3: Door osf
Chipped
Edge Chip

4: Door osr
Scratched
Over 25mm Not Thru Paint

5: Door osr
Scratched
UpTo 25mm Thru Paint

6: Qtr Panel osr
Scratched
UpTo 25mm Not Thru Paint

7: Door nsr
Scratched
Over 25mm Not Thru Paint

8: Door nsf
Chipped
Edge Chip

9: Door nsf
Scratched
Over 25mm Not Thru Paint

10: Wing nsf
Scratched
Over 25mm Not Thru Paint

11: Bumper Front
Scratched
Over 25mm Not Thru Paint

12: Bumper Rear Moulding
Scuffed (Unpainted)
UpTo 100mm

13: Qtr Panel osr
Chipped
1 To 5
