VEHICLE INSPECTION REPORT

GV19RAU

Kia Stonic 1.0T GDi 3 5dr

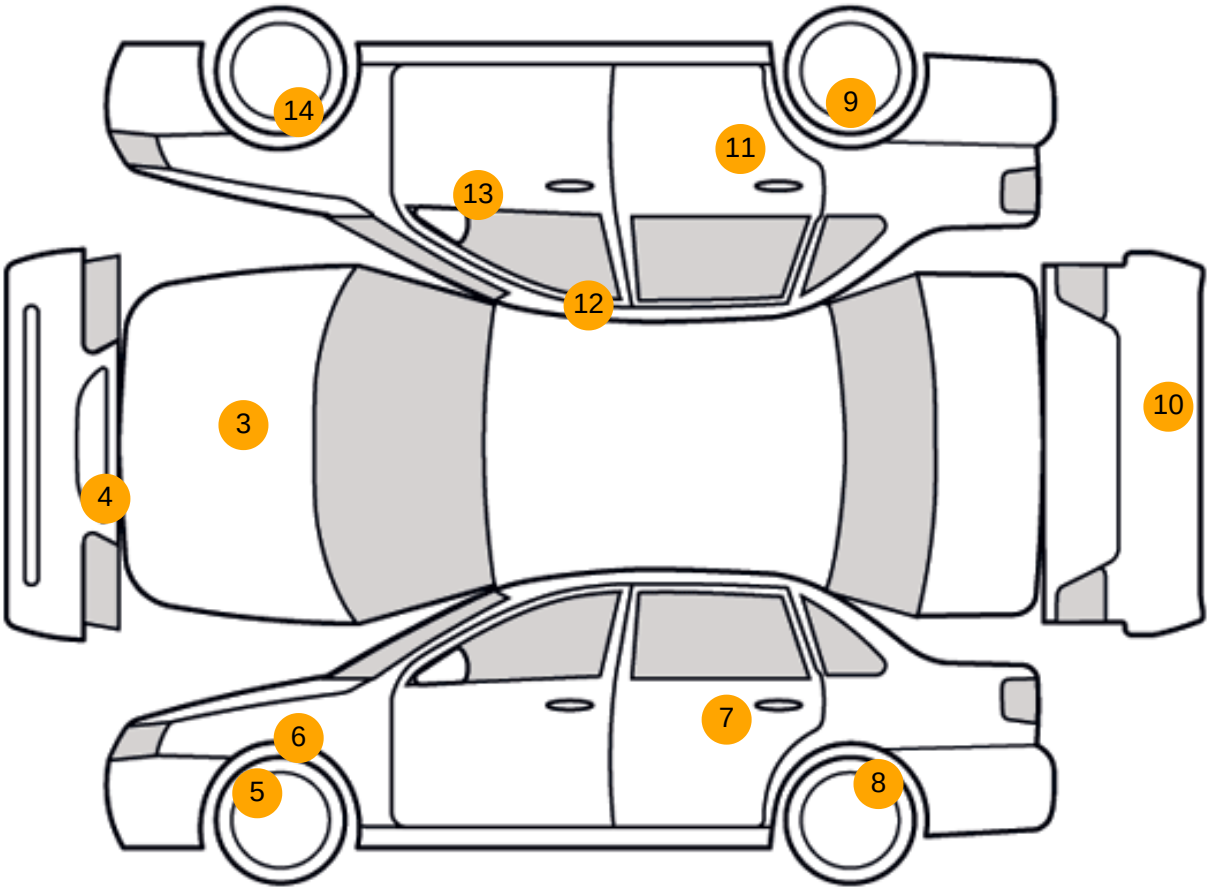
Condition Check

1: Seat Base Cover osf
Scuffed
Over 25mm

2: Carpets Front
Holed
Over 3mm

3: Bonnet
Chipped
1 To 5

4: Bumper Front
Chipped
Multiple Chips

5: Wheel nsf
Scratched
Over 50mm

6: Wing nsf
Chipped
1 To 5

7: Door nsr
Chipped
1 To 5

8: Wheel nsr
Scratched
Over 50mm

9: Wheel osr
Scratched
Over 50mm

10: Bumper Rear
Scratched
Up To 25mm Thru Paint

11: Door osr
Scratched
Over 25mm Thru Paint

12: A Post os
Dented
Between 10mm + 30mm

13: Door osf
Dented
Over 30mm

14: Wheel osf
Scratched
Over 50mm
