# VEHICLE INSPECTION REPORT

**LY12DFZ**

## Nissan Qashqai 1.6 [117] N-Tec+ 5dr

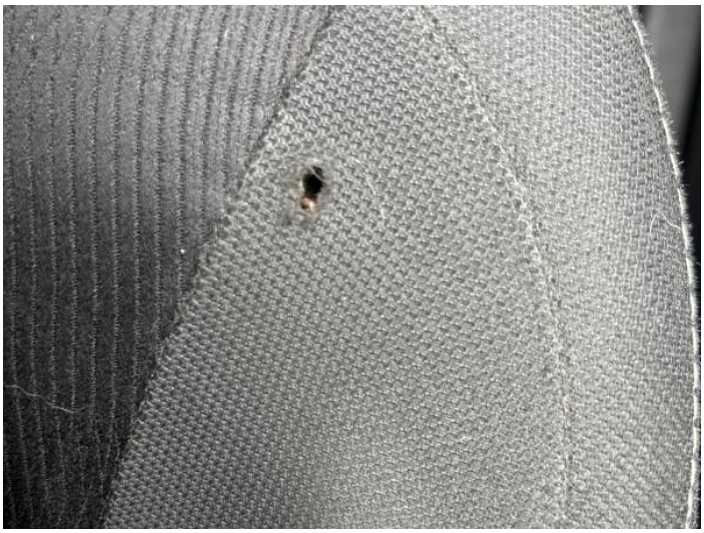
1: Seat Base Cover nsf
Holed
UpTo 3mm
