VEHICLE INSPECTION REPORT

KS64DHY

Nissan Qashqai 1.2 DiG-T Acenta Premium 5dr

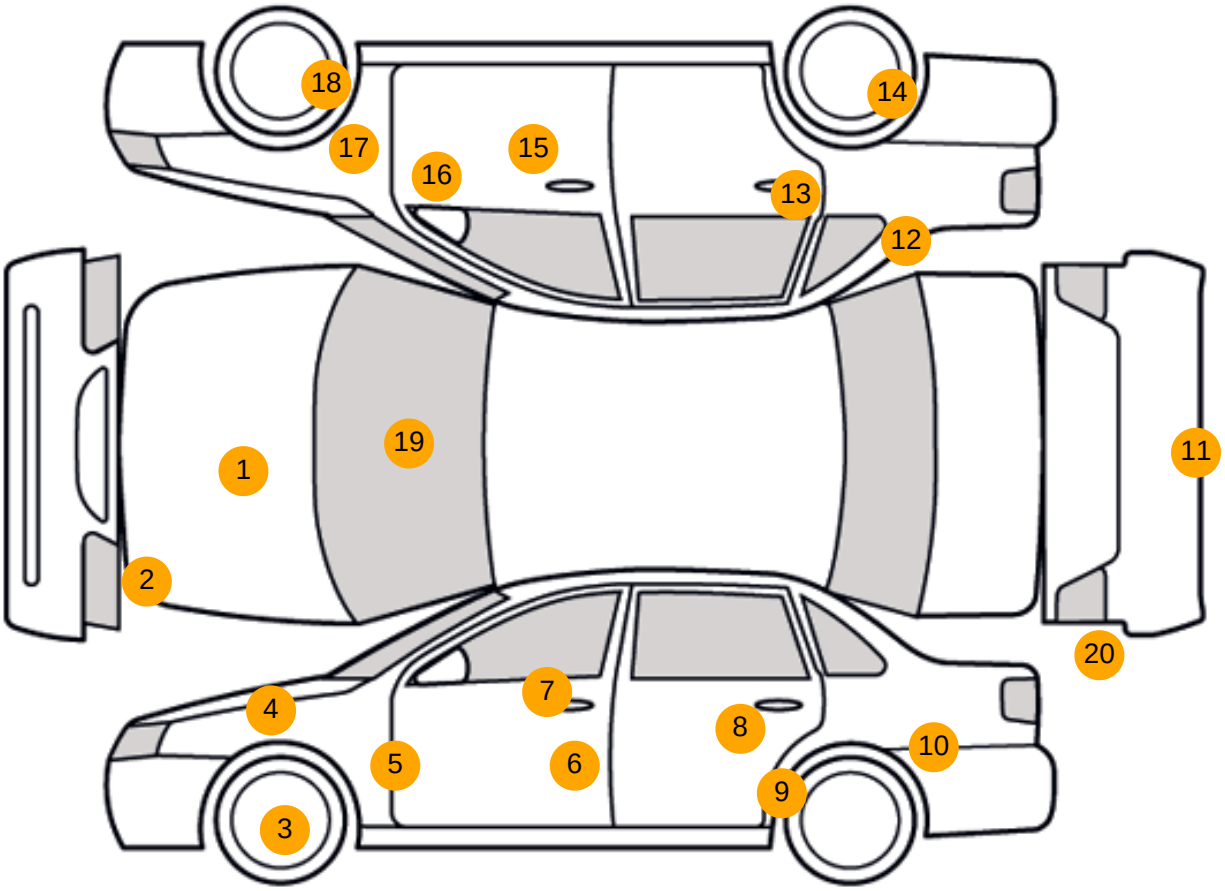
Condition Check

1: Bonnet
Scratched
Over 25mm Thru Paint

3: Wheel nsf
Scratched
Over 50mm

4: Wing nsf
Chipped
1 To 5

5: Wing Front Arch Extension ns
Scuffed (Unpainted)
UpTo 100mm

6: Door nsf
Dented
Between 10mm + 30mm

7: Door nsf
Chipped
1 To 5

8: Door nsr
Dented
Over 30mm

9: Door nsr
Chipped
1 To 5

10: Qtr Panel osr
Scratched
UpTo 25mm Thru Paint

11: Bumper Rear
Scratched
25 to 100mm Thru Paint

12: Qtr Panel osr
Scratched
Over 25mm Thru Paint

13: Door osr
Dented
Over 30mm

14: Wheel osr
Scratched
Up To 50mm

15: Door osf
Dented
Between 10mm + 30mm

16: Door osf
Scratched
UpTo 25mm Thru Paint

17: Wing osf
Dented
With Paint Damage

18: Wheel osf
Scratched
Over 50mm

19: Screen Front
Chipped
UpTo 10mm

20: Lamp osr
Broken
Replace
