# VEHICLE INSPECTION REPORT

**YB12CYF**

## Mini Clubman 1.6 Cooper 5dr

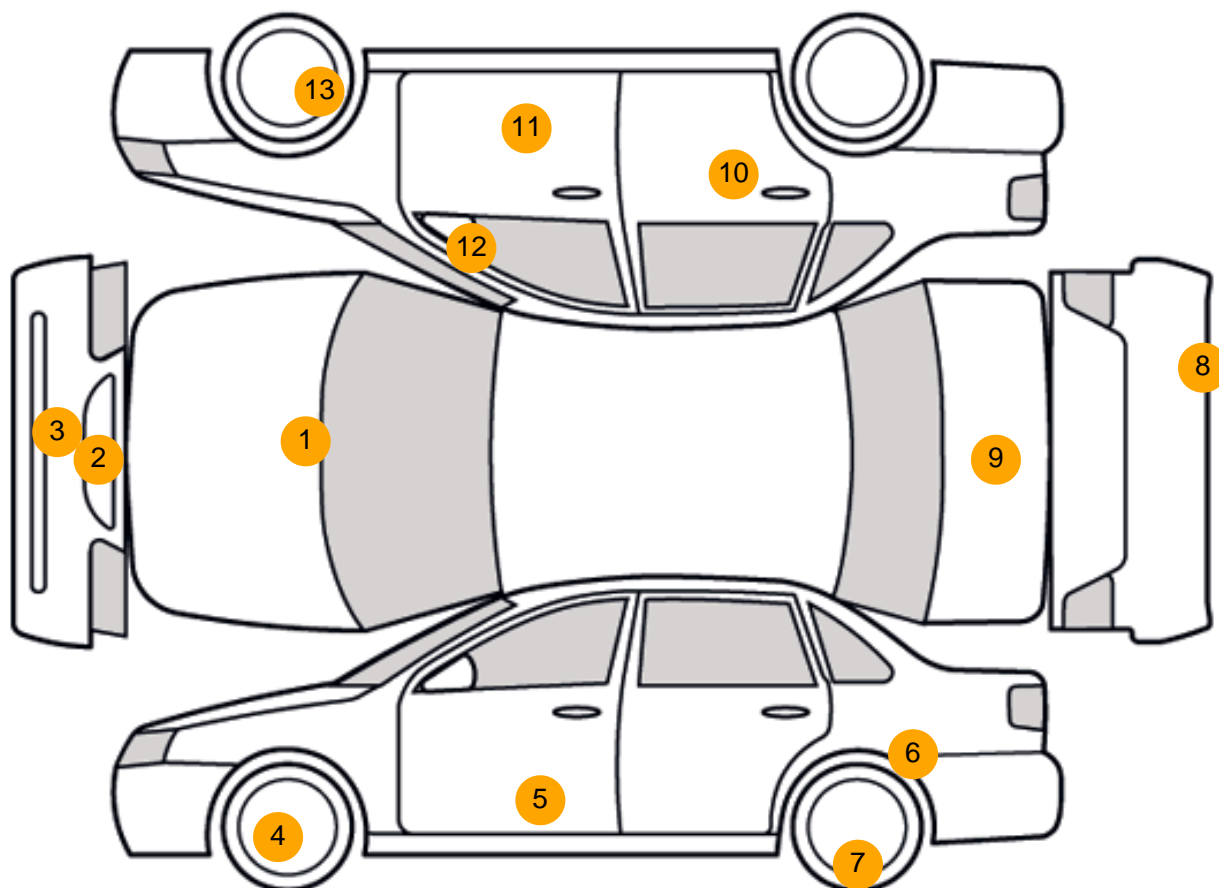
## Condition Check

£100 ADDITIONAL FEE Last service 07/02/2022 @ 58510 miles (2 SERVICES) Engine noisy and brake warning light on dash  
Drivers window fault
