# VEHICLE INSPECTION REPORT

**DV67VNP**

## Vauxhall Astra 1.4i 16V Design 5dr

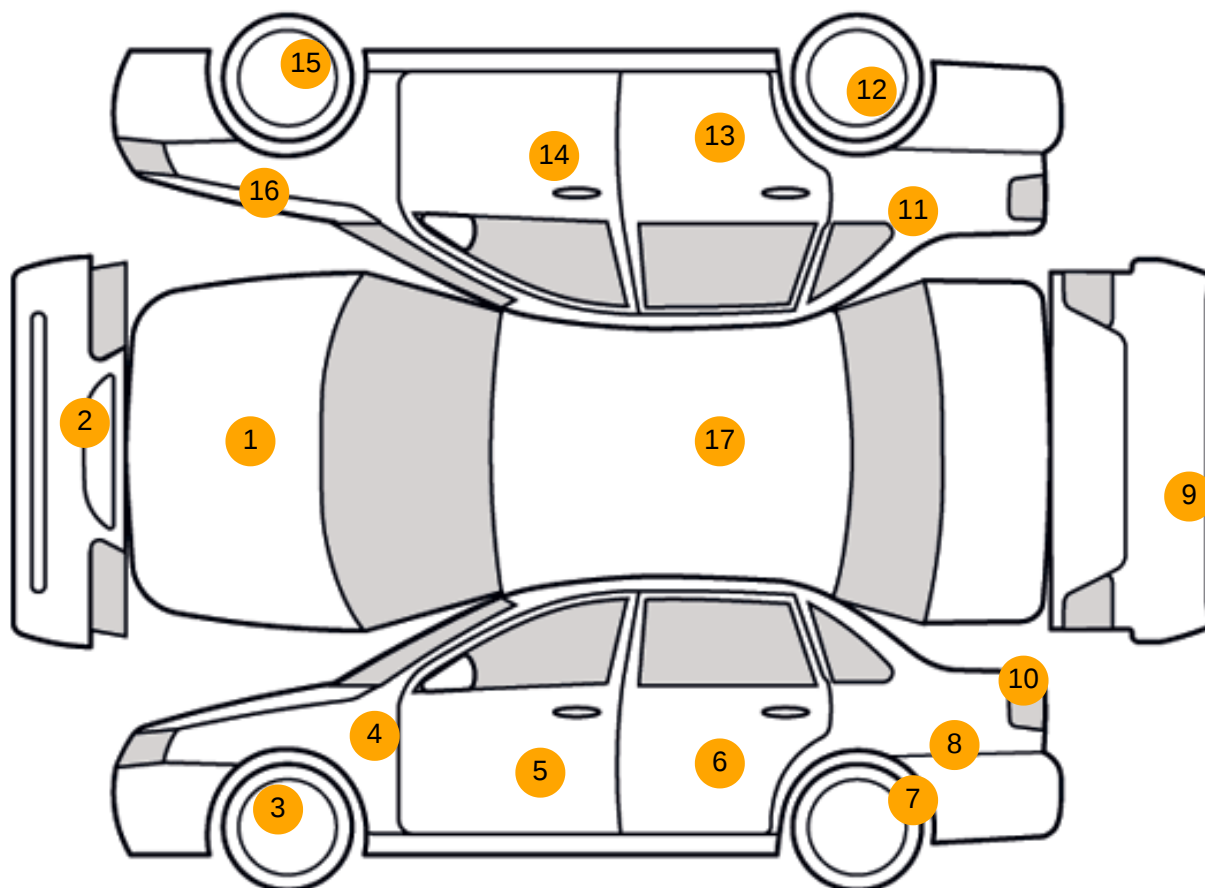
## Condition Check

Last service 01/04/2021 at 25,509 miles- 2 services Eml light is on  
Car been plugged in and detected  
Clutch Pedal Position Sensor 'A' Circuit Range/Performance issue  
Service due message displayed  
Front suspension knocking  
Intermittent starter motor fault
