VEHICLE INSPECTION REPORT

HW18KPU

Ford Kuga 2.0 TDCi 180 Titanium 5dr Auto

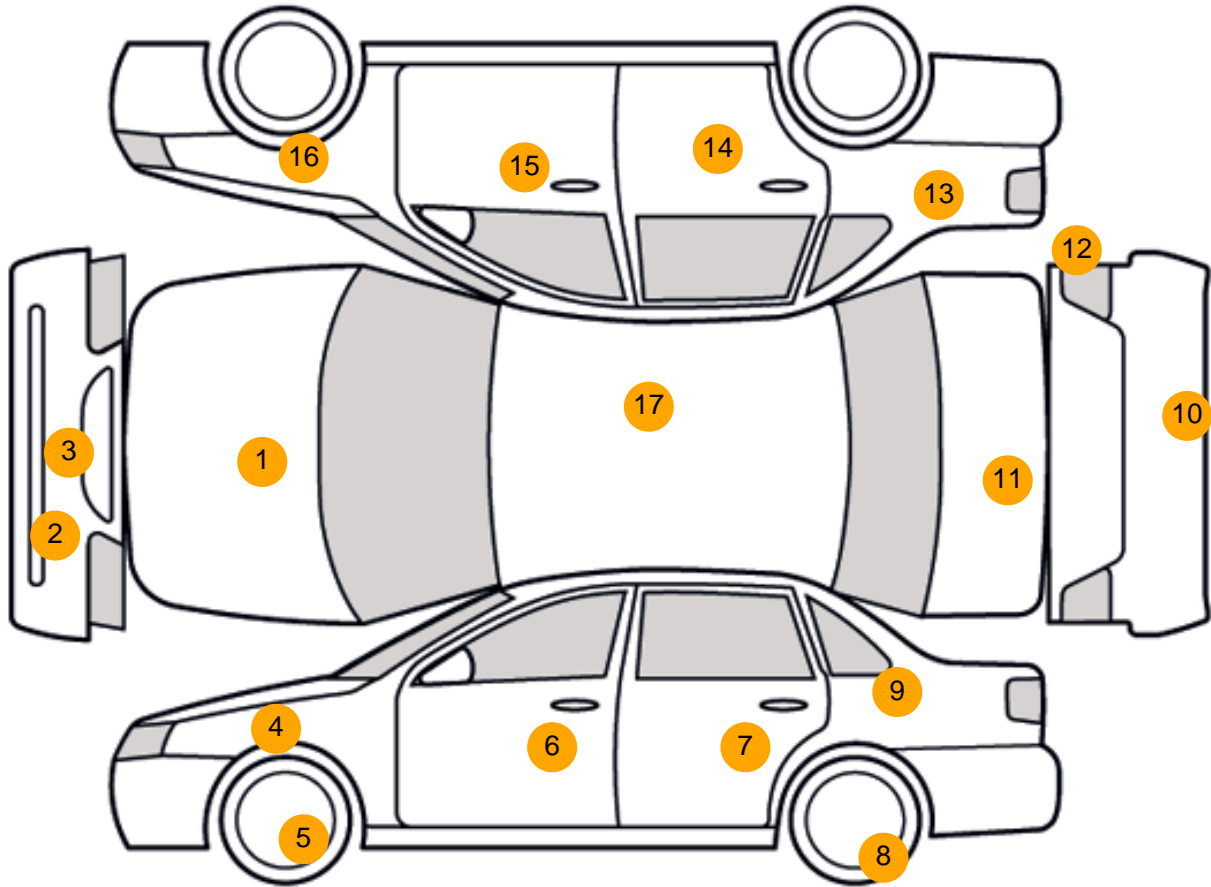
Condition Check

2: Bumper Front
Cracked
Over 25mm

3: Fog Lamp Surround ns
Broken
Replace

12: Lamp nsr
Broken
Replace

18: Tyre nsf
Damaged
Replace
