VEHICLE INSPECTION REPORT

FA15AZC

Nissan Qashqai 1.5 dCi [110] Acenta 5dr

nama
GRADE
5

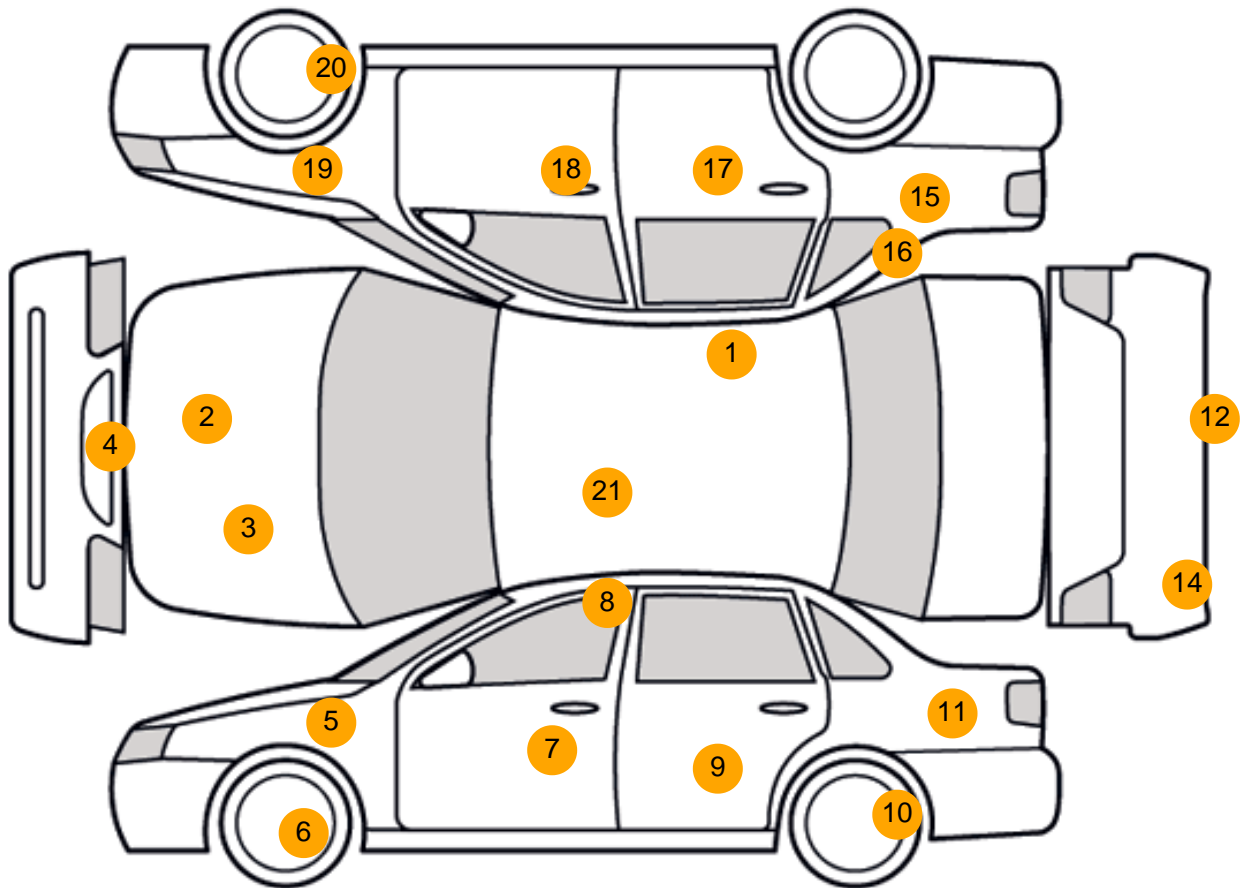
Condition Check

8: Aperture Seal nsf
Broken
Replace

9: Door nsr
Dented
With Paint Damage

11: Qtr Panel osr
Dented
With Paint Damage
