# VEHICLE INSPECTION REPORT

**HV11ZYY**

## Hyundai I10 1.2 Classic 5dr

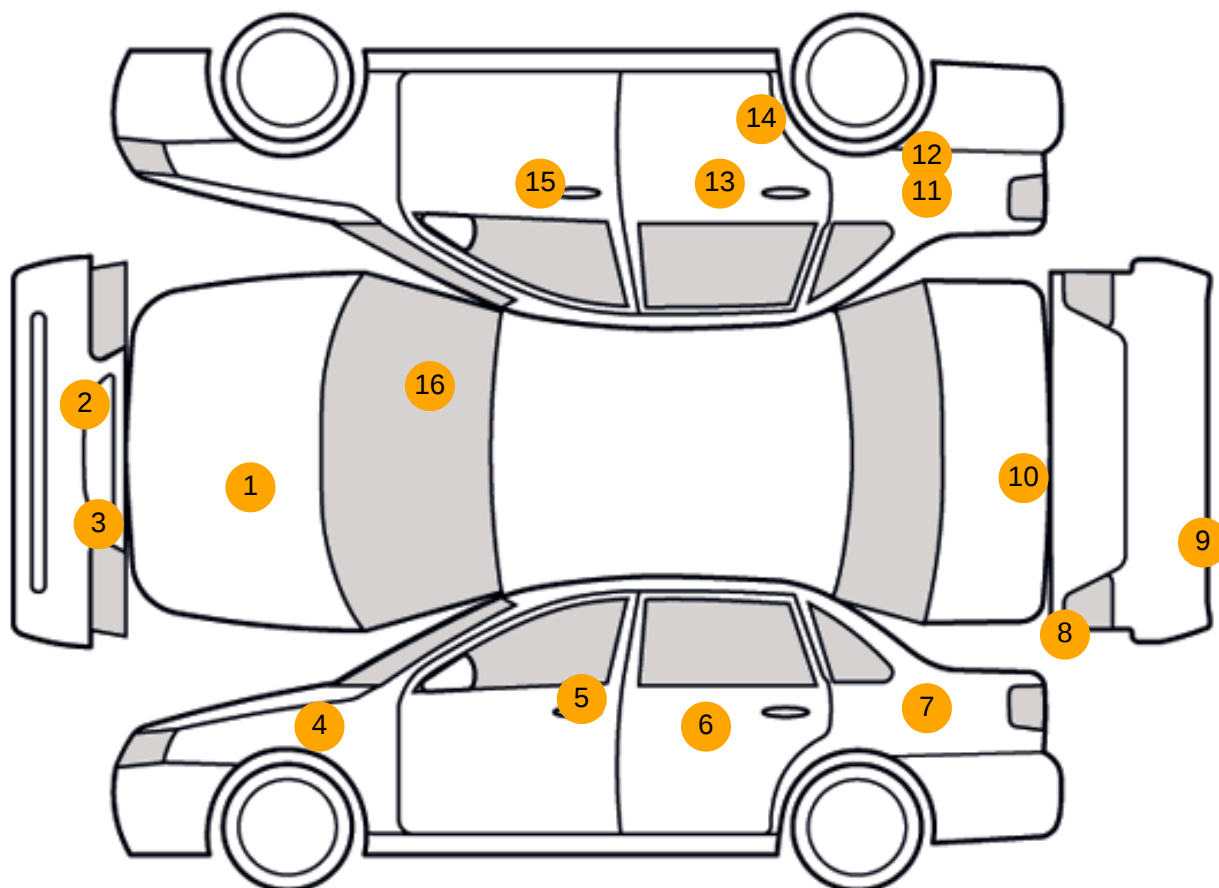
## Condition Check

2: Number Plate Front  
Broken  
Replace

6: Door nsr  
Dented  
With Paint Damage

7: Qtr Panel nsr  
Dented  
With Paint Damage

8: Lamp nsr  
Broken  
Replace
