## VEHICLE INSPECTION REPORT

**GX21LUF**

### Ford Fiesta 1.0 EcoBoost 95 Titanium 5dr

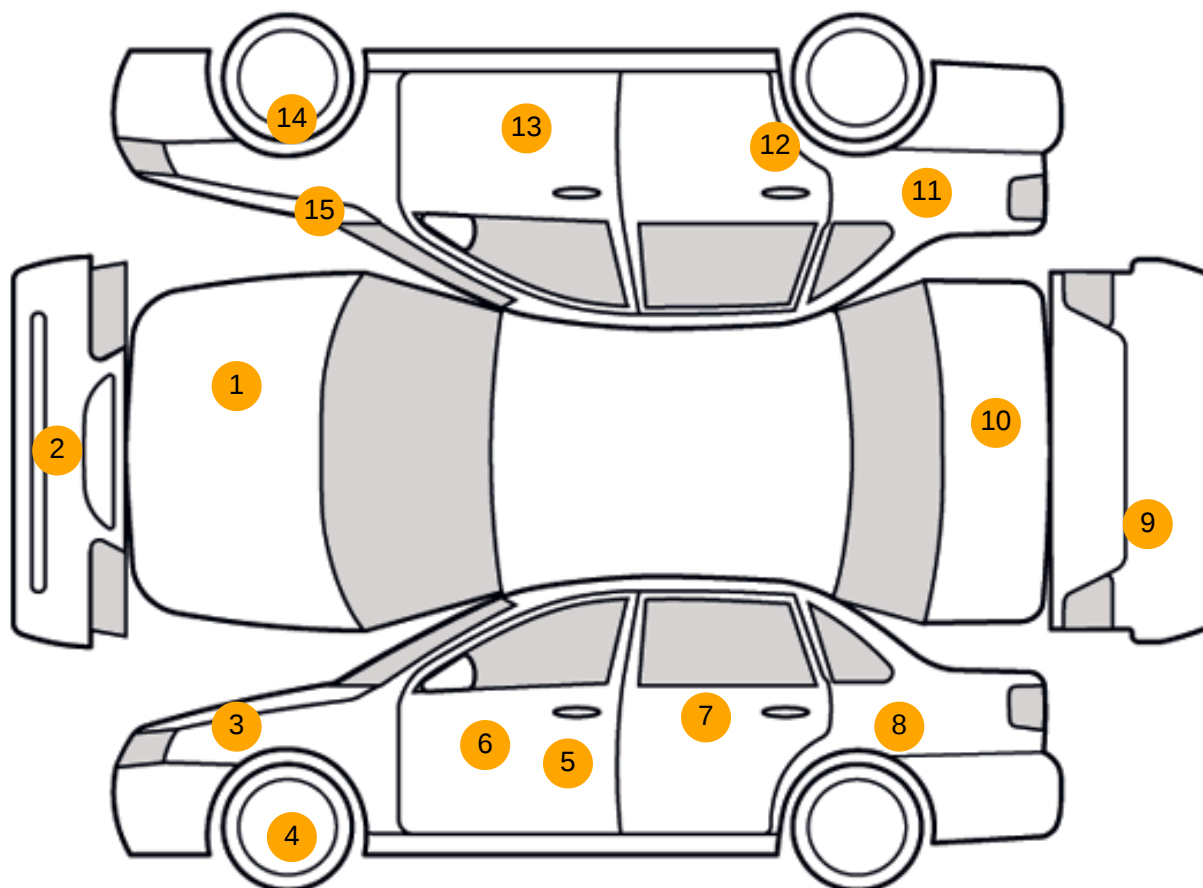
## Condition Check

2: Bumper Front  
Dented  
With Paint Damage

7: Door nsr  
Dented  
With Paint Damage

11: Qtr Panel osr  
Dented  
With Paint Damage

12: Door osr  
Dented  
With Paint Damage

13: Door osf  
Dented  
With Paint Damage
