# VEHICLE INSPECTION REPORT

**PO14WDS**

## Nissan Juke 1.6 Tekna 5dr CVT

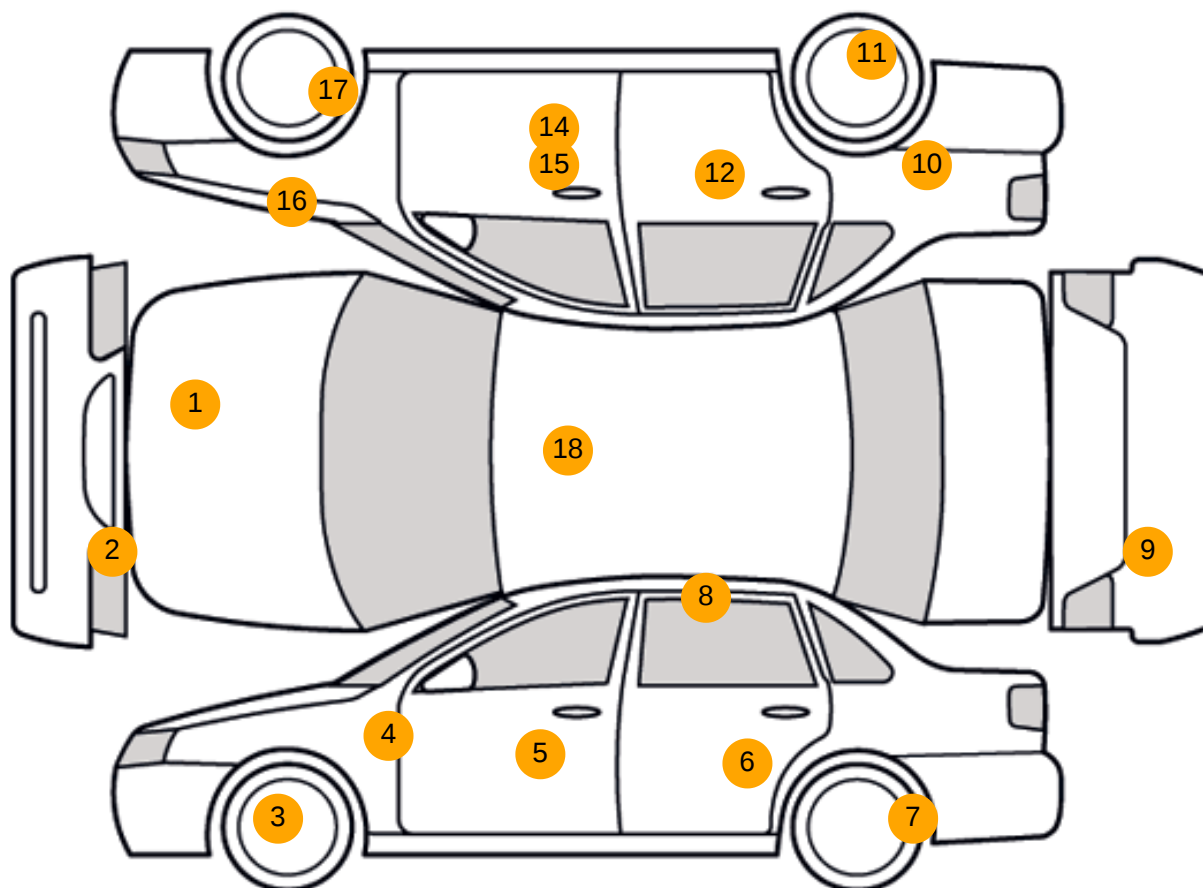
4: Wing nsf  
Poor Previous Repair  
Poor Paint

5: Door nsf  
Poor Previous Repair  
Rippled UpTo 30%

13: Tyre nsf  
Damaged  
Replace
